**BMW 5: 1FJX232**

**Limited Technical Inspection**

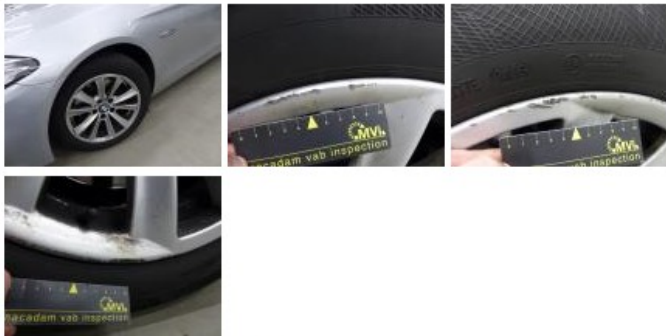
Alloy rim F L, Scratch(es), LI - Repair and paint (complete)	<b>95,00</b>
--	--------------

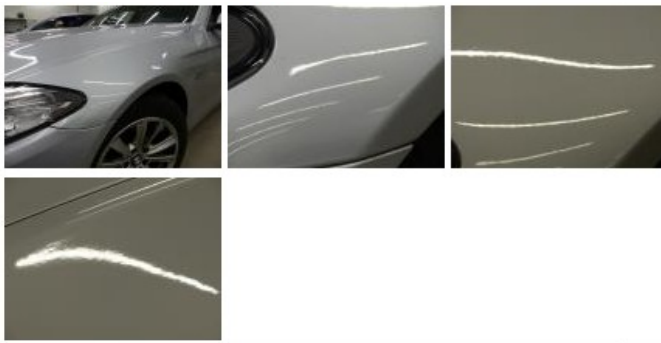
Wing F L, Bad repair, Acceptable 0,00

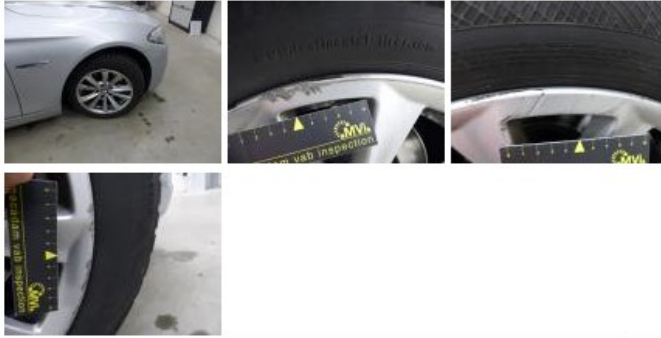
Bonnet, Bump(s), Acceptable	0,00
<i>No pictures to display</i>	
Bumper corner R L, Scratch(es), Acceptable	0,00
<i>No pictures to display</i>	
Bumper R, Scratch(es), Acceptable	0,00
<i>No pictures to display</i>	
Alloy rim F R, Scratch(es), LI - Repair and paint (complete)	95,00
