BMW X1: 1EHG235			
Vinnnumber:	WBAVN710X0VW78706	Versionname:	X1 sDrive18 136PK Aut.
First Registrationdate:	3/12/2012	Fiscalpower:	
Expertise Mileage:	133902	Power Kw:	100
Bodytype:	Hatchback	Body color:	White
Gearbox:	Automatic	Paint type:	Metalic
Transmission:	Front	Rims summer:	Aluminium
Fueltype:	Diesel	Oil level:	OK
Battery functioning:	Yes	Parking lot:	3472
Number of doors:	5		
Number of seats:	5		
Number head rests:	5		
Rims summer:	Aluminium		
Category:	Passenger Car		
Oil level:	OK		
Registration Certificate Car (BE):	No

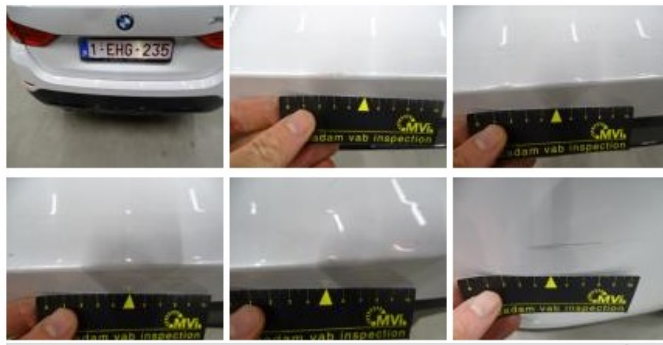
Bumper R, Scratch(es), LI - Repair and paint (complete)	211,80
---	--------
