MERCEDES A: 1FON240			
Vinnumber:	WDD1760121J171346	Versionname:	A 180 CDI BE 109PK
First Registrationdate:	6/09/2013	Fiscalpower:	
Expertise Mileage:	71938	Power Kw:	80
Bodytype:	Hatchback	Body color:	Black
Gearbox:	MAN 6 VIT	Paint type:	Metalic
Transmission:		Rims summer:	Aluminium
Fueltype:	Diesel	Oil level:	OK
Battery functioning:	Yes	Parking lot:	2725
Number of doors:	5		
Number of seats:	5		
Number head rests:	5		
Rims summer:	Aluminium		
Category:	Passenger Car		
Oil level:	OK		
Registration Certificate Car (BE):	Yes

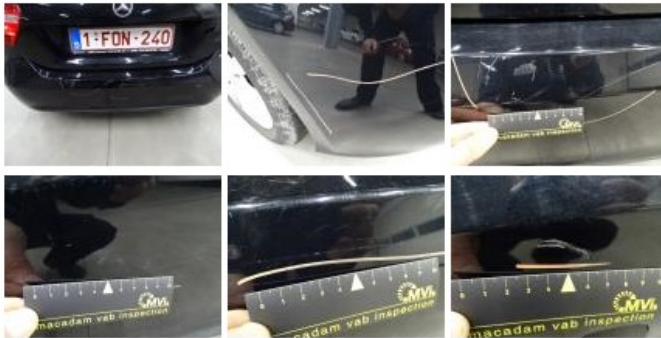
Bumper R, Scratch(es), LI - Repair and paint (complete) 211,80

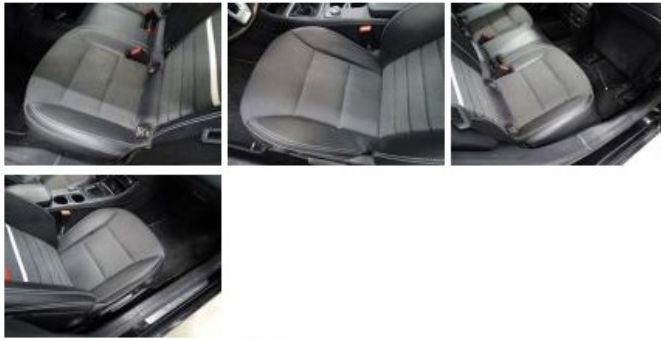
Interior, Dirty, Cleaning	48,00
---------------------------	-------
