FORD S Max: 1BOL931			
Vinnnumber:	<b>WF0SXXGBWSBY31243</b>	Versionname:	<b>S-MAX Econetic Trend St&amp;St DPF 115PK</b>
First Registrationdate:	<b>18/07/2011</b>	Fiscalpower:	
Expertise Mileage:	<b>203145</b>	Power Kw:	<b>85</b>
Bodytype:	<b>MPV</b>	Body color:	<b>White</b>
Gearbox:	<b>MAN 6 VIT</b>	Paint type:	<b>Opaque</b>
Transmission:		Rims summer:	<b>Aluminium</b>
Fueltype:	<b>Diesel</b>	Oil level:	<b>OK</b>
Battery functioning:	<b>Yes</b>	Parking lot:	<b>1209</b>
Number of doors:	<b>5</b>		
Number of seats:	<b>5</b>		
Number head rests:	<b>5</b>		
Rims summer:	<b>Aluminium</b>		
Category:	<b>Passenger Car</b>		
Oil level:	<b>OK</b>

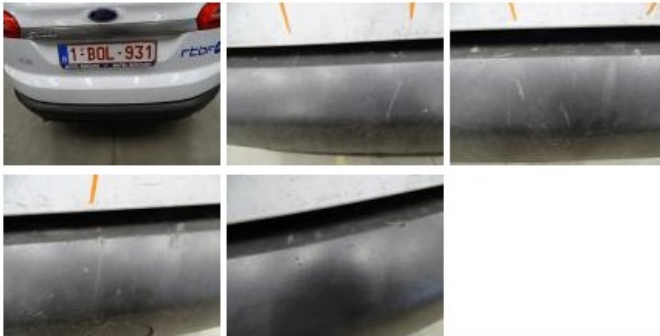
Bumper R, Scratch(es), Smart repair 110,64
