**OPEL Astra: 1BBB847**

**Limited Technical Inspection**

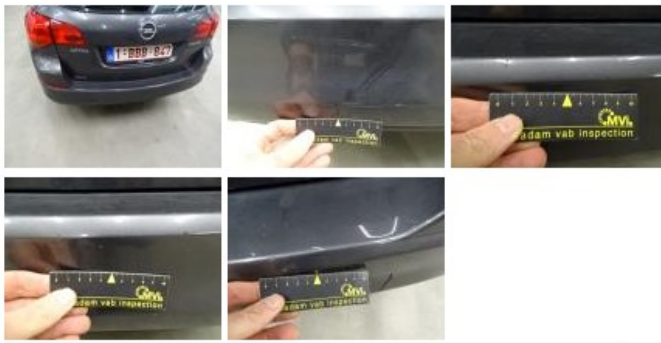
Bumper R, Scratch(es), LI - Repair and paint (complete)	<b>211,80</b>
---	---------------

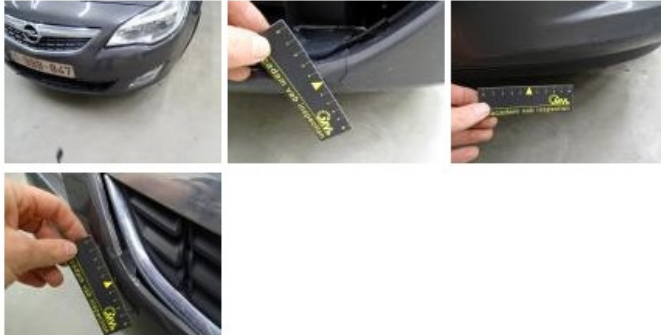
Front bumper, Crack, E - Replace 499,20

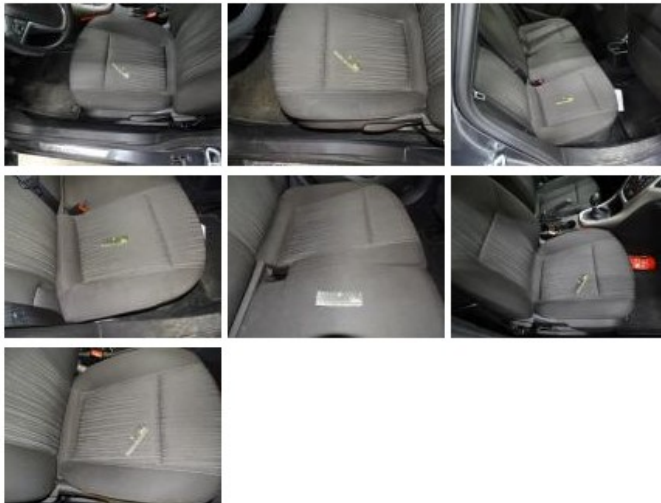
Interior, Dirty, Cleaning 50,00

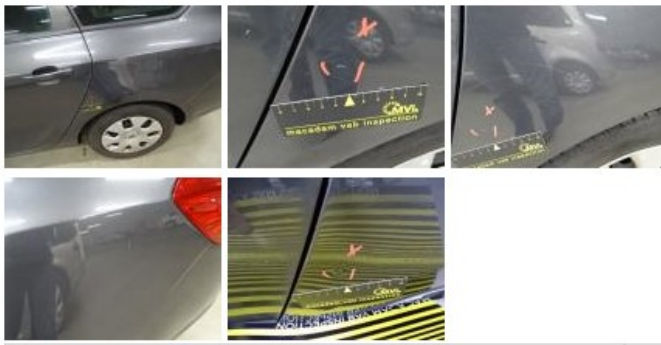
Wing R L - Bump(s) and scratch(es), LI - Repair and paint (complete) 308,20

Wing (L), Camp(s) and scratch(es), LI - Repair and paint (complete)

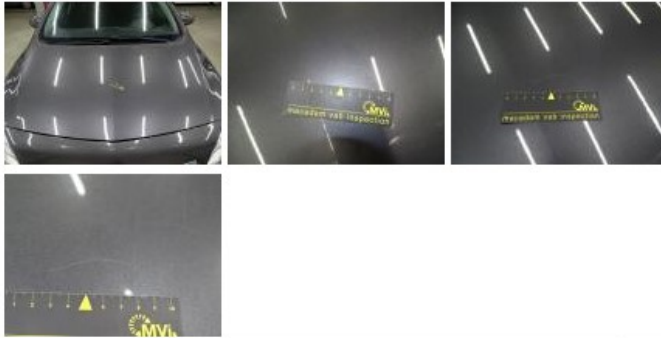
Bonnet, Scratch(es), LI - Repair and paint (complete) 290,08
