VOLVO V40: 1FRG577			
Vinnnumber:	<b>YV1MV8481E2099636</b>	Versionname:	<b>V40 D2 Base 115PK</b>
First Registrationdate:	<b>1/10/2013</b>	Fiscalpower:	
Expertise Mileage:	<b>66926</b>	Power Kw:	<b>84</b>
Bodytype:	<b>Hatchback</b>	Body color:	<b>Black</b>
Gearbox:	<b>MAN 6 VIT</b>	Paint type:	<b>Metalic</b>
Transmission:	<b>Front</b>	Rims summer:	<b>Aluminium</b>
Fueltype:	<b>Diesel</b>	Oil level:	<b>OK</b>
Battery functioning:	<b>Yes</b>	Parking lot:	<b>2106</b>
Number of doors:	<b>5</b>		
Number of seats:	<b>5</b>		
Number head rests:	<b>5</b>		
Rims summer:	<b>Aluminium</b>		
Category:	<b>Passenger Car</b>		
Oil level:	<b>OK</b>		
Registration Certificate Car (BE):	<b>Yes</b>

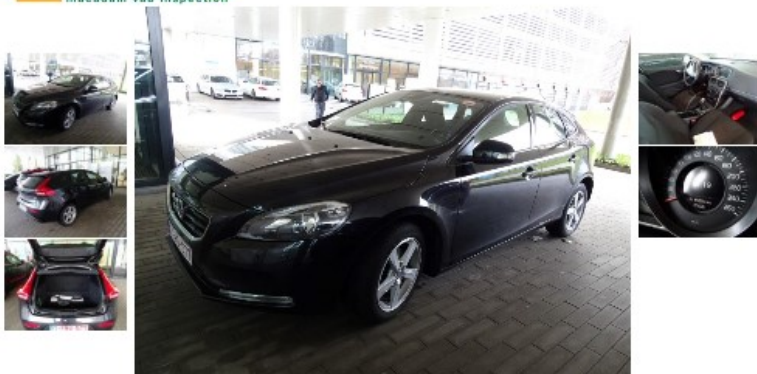
Assistance equipment			
Repair kit	<b>Yes</b>	Compressor	<b>Yes</b>
Total cost ex VAT			<b>608,48</b>
Bumper R, Chemical polution, LI - Repair and paint (complete)			<b>211,80</b>

Tailgate, Bump(s), LI - Repair and paint (complete)			<b>301,68</b>
