BMW 1: 1GDV448

Limited Technical Inspection

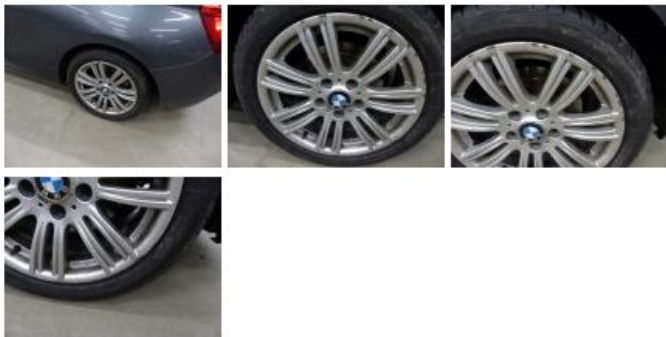
| Alloy rim R L, Scratch(es), LI - Repair and paint (complete) | | 95,00 |
