RENAULT CLIO: 1PVF704

Limited Technical Inspection

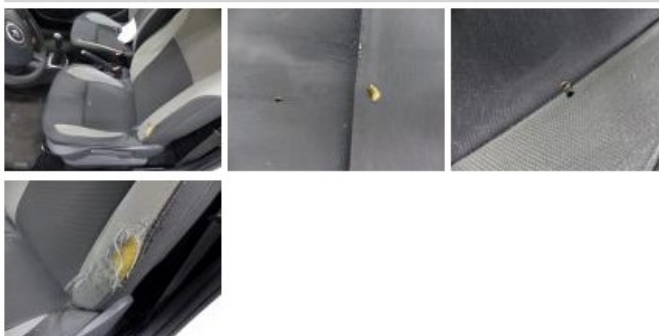
Seat cover F L, Damaged, E - Replace	312,00
--------------------------------------	--------

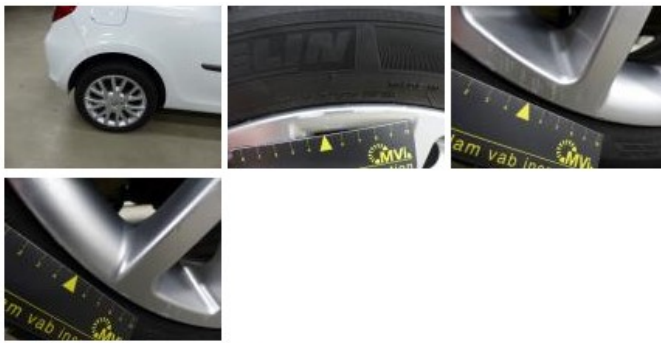
Alloy rim R R, Scratch(es), LI - Repair and paint (complete)	95,00
--	-------

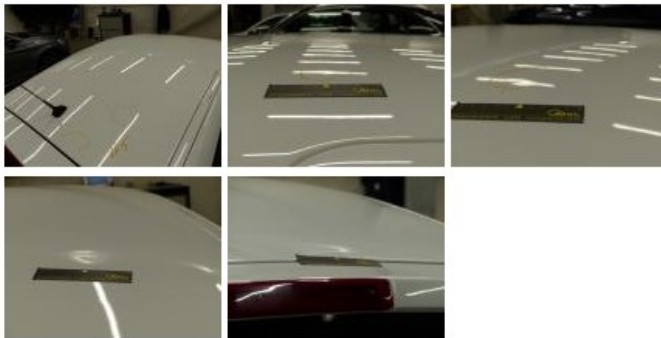
Roof, Hail damage, PDR - Hail 125,00

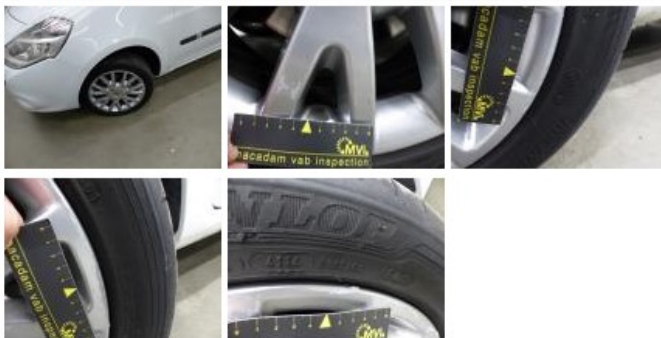
Alloy rim F L, Scratch(es), LI - Repair and paint (complete) 95,00

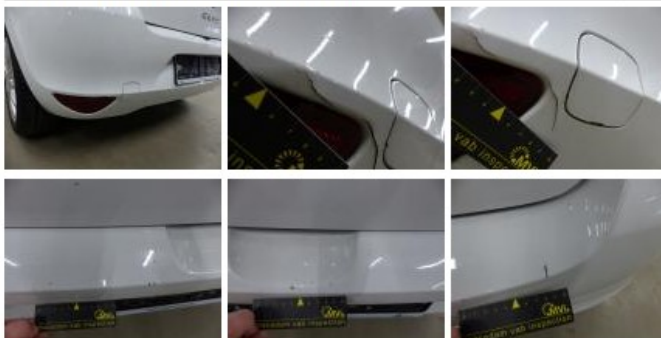
Bumper R, Broken, Le - Replace and paint 535,20

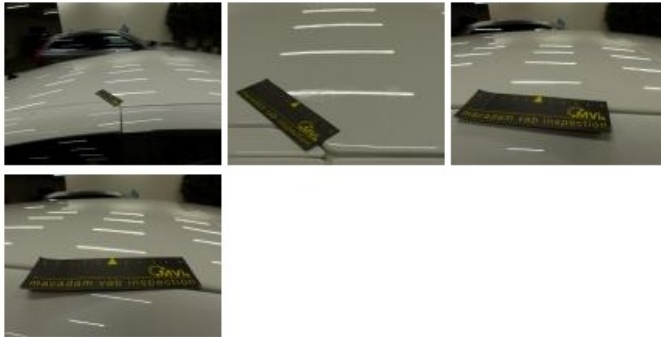
Roof, Bad repair, Acceptable 0,00

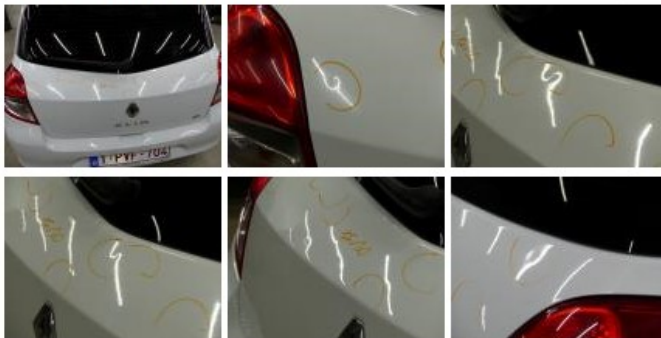
Tailgate, Hail damage, PDR - Hail 250,00

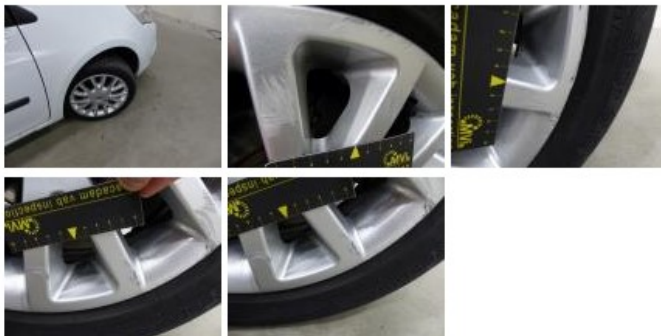
Alloy rim F R, Scratch(es), LI - Repair and paint (complete) 95,00
