<b>MERCEDES E: 1DDF842</b>			
Vinnumber:	<b>WDD2120051A629411</b>	Versionname:	<b>E BER 200CDI BE</b>
First Registrationdate:	<b>16/04/2012</b>	Fiscalpower:	<b>Start/Stop 136PK</b>
Expertise Mileage:	<b>204396</b>	Power Kw:	<b>100</b>
Bodytype:		Body color:	<b>Grey</b>
Gearbox:	<b>MAN 6 VIT</b>	Paint type:	<b>Metalic</b>
Transmission:		Rims summer:	<b>Aluminium</b>
Fueltype:	<b>Diesel</b>	Oil level:	<b>OK</b>
Battery functioning:	<b>Yes</b>	Parking lot:	<b>2607</b>
Number of doors:	<b>4</b>		
Number of seats:	<b>5</b>		
Number head rests:	<b>5</b>		
Rims summer:	<b>Aluminium</b>		
Category:	<b>Passenger Car</b>		
Oil level:	<b>OK</b>

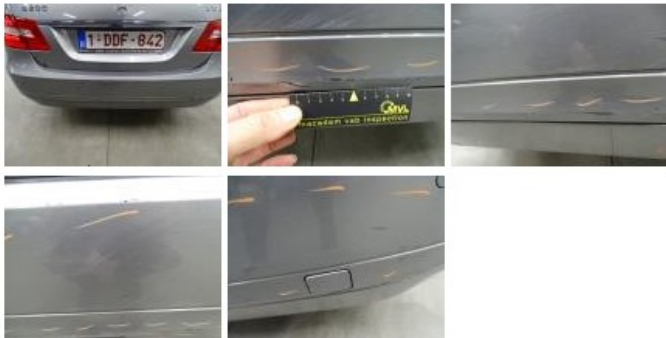
Total cost ex VAT	<b>1646,48</b>
Bumper R, Scratch(es), LI - Repair and paint (complete)	<b>211,80</b>

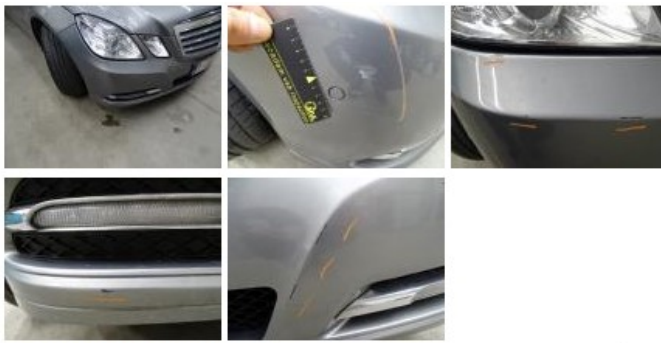
Door F L, Scratch(es), Acceptable	<b>0,00</b>
<i>No pictures to display</i>	
Front bumper, Scratch(es), LI - Repair and paint (complete)	<b>211,80</b>
