**BMW 5: 1GAL897**

**Limited Technical Inspection**

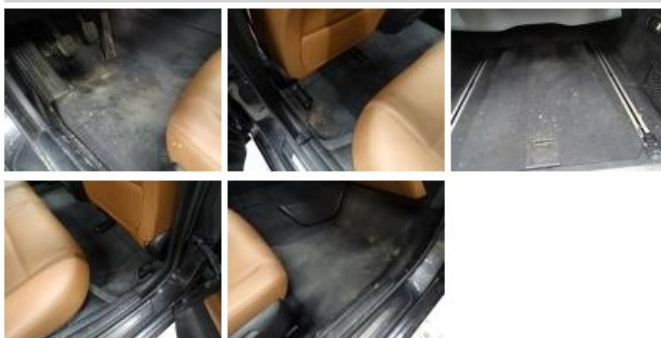
Interior, Dirty, Cleaning 48,00
