BMW 3: 1DJT243			
Vinnumber:	WBA3D91010F401202	Versionname:	3 BER 316d 116PK
First Registrationdate:	5/06/2012	Fiscalpower:	
Expertise Mileage:	81985	Power Kw:	85
Bodytype:		Body color	Black
Gearbox:	MAN 6 VIT	Paint type	Metalic
Transmission:		Rims summer	Aluminium
Fueltype:	Diesel	Oil level	OK
Battery functioning	Yes	Parking lot	4719
Number of doors	4		
Number of seats	5		
Number head rests	5		
Rims summer	Aluminium		
Category	Passenger Car		
Oil level	OK

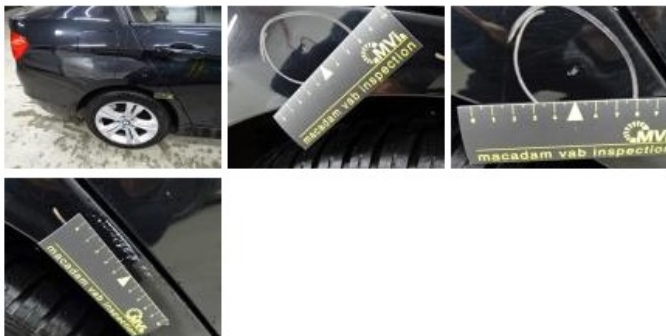
Assistance equipment	
Total cost ex VAT	2065,67
Wing R R, Bump(s) and scratch(es), LI - Repair and paint (complete)	308,20
