BMW 116d: 1FEK053			
Vinnumber:	WBA1N31060J710954	Versionname:	SPORTSHATCH
First Registrationdate:	6/06/2013	Fiscalpower:	
Expertise Mileage:	161329	Power Kw:	85
Bodytype:		Body color:	Blue
Gearbox:	MAN 6 VIT	Paint type:	Metalic
Transmission:	Back	Rims summer:	Aluminium
Fueltype:	Diesel	Oil level:	OK
Battery functioning:	Yes		
Number of doors:	3		
Number of seats:	4		
Number head rests:	4		
Rims summer:	Aluminium		
Category:	Passenger Car		
Oil level:	OK

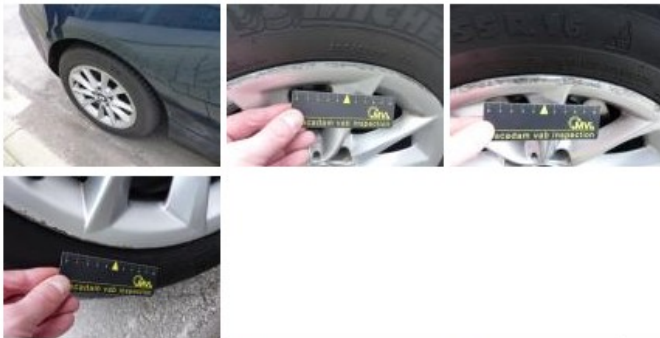
Alloy rim R R, Scratch(es), LI - Repair and paint (complete) 95,00

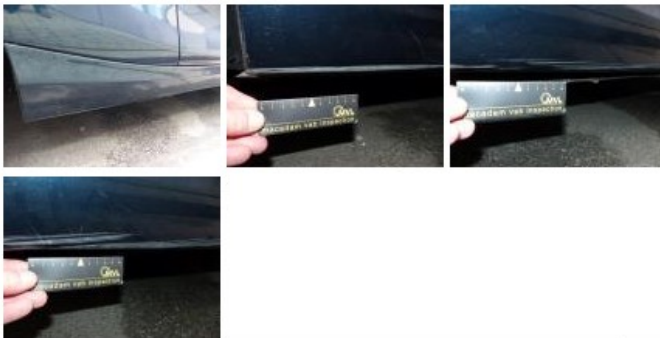
Sill outer R, Scratch(es), LI - Repair and paint (complete) 310,50
