BMW 3: 1FMJ216

| Vinnumber: | WBA3D11000J623941 | Versionname: | 3 BER 318d 136PK |

Limited Technical Inspection

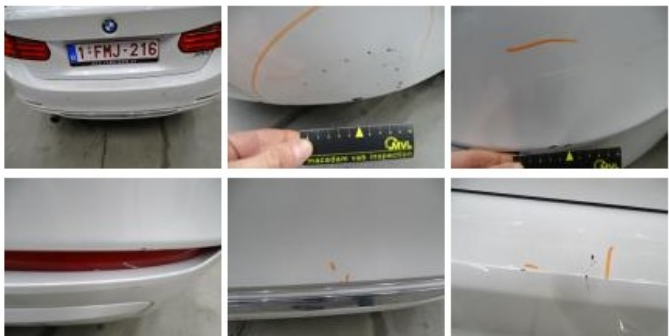
| Bumper R, Scratch(es), LI - Repair and paint (complete) | 211,80 |

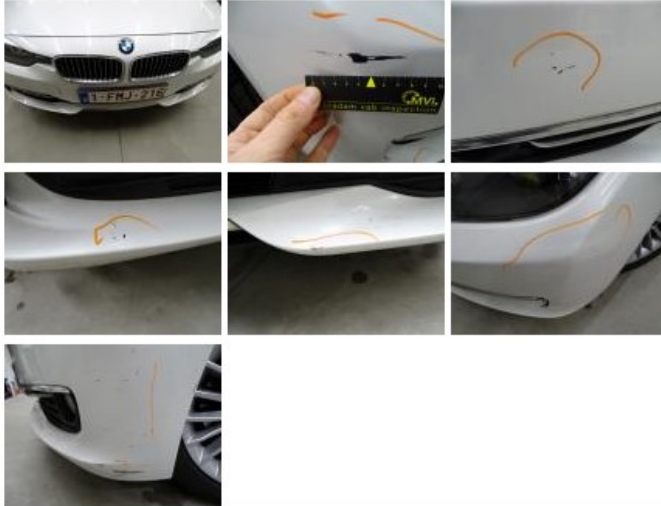
Front bumper, Scratch(es), LI - Repair and paint (complete) 211,80
