| MERCEDES A: 1HPK387 | | | |
| Vinnnumber: | <b>WDD1760111V028412</b> | Versionname: | <b>A 160 CDI 90PK</b> |

| Limited Technical Inspection | | | |

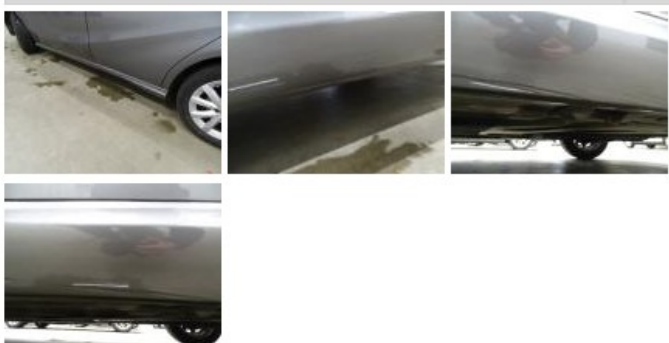
| Sill outer L, Scratch(es), LI - Repair and paint (complete) | 310,50 |
