**OPEL Vivaro 2900: 1DOL444**

**Limited Technical Inspection**

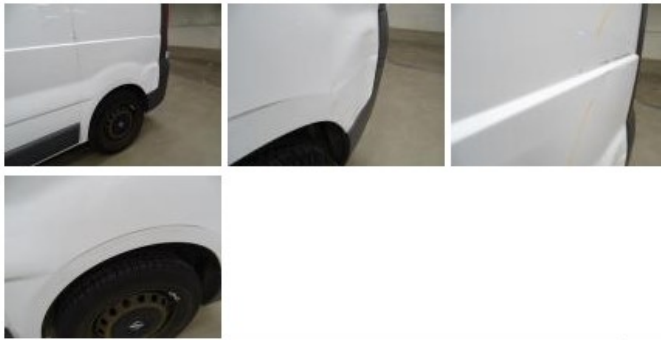
Wing R L, Bump(s) and scratch(es), LI - Repair and paint (complete) 231,15

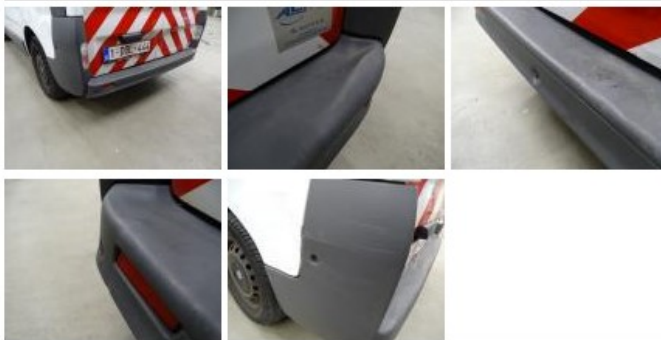
Bumper R, Bump(s) and scratch(es), E - Replace 329,40
