VOLVO V60: 1ERR459			
Vinnumber:	<b>YV1FW84A1D1130497</b>	Versionname:	<b>V60 D2 Kinetic St/St 115PK</b>
First Registrationdate:	<b>4/03/2013</b>	Fiscalpower:	
Expertise Mileage:	<b>174759</b>	Power Kw:	<b>84</b>
Bodytype:	<b>Break</b>	Body color:	<b>Black</b>
Gearbox:	<b>MAN 6 VIT</b>	Paint type:	<b>Metalic</b>
Transmission:	<b>Front</b>	Rims summer:	<b>Aluminium</b>
Fueltype:	<b>Diesel</b>	Oil level:	<b>OK</b>
Battery functioning:	<b>Yes</b>	Parking lot:	<b>1111</b>
Number of doors:	<b>5</b>		
Number of seats:	<b>5</b>		
Number head rests:	<b>5</b>		
Rims summer:	<b>Aluminium</b>		
Category:	<b>Passenger Car</b>		
Oil level:	<b>OK</b>

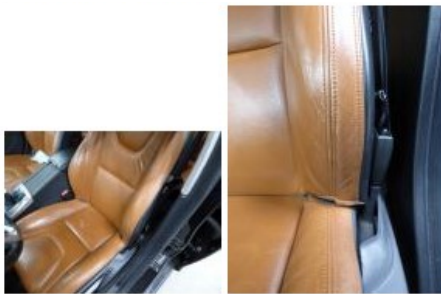
Seat cover F L, Damaged, Acceptable	0,00
-------------------------------------	------

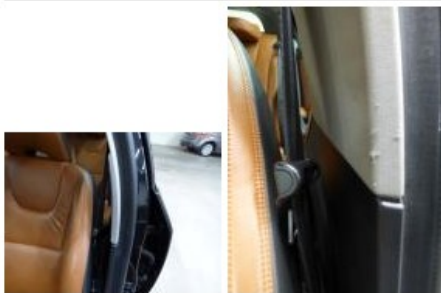
Covering interior front pillar L, Scratch(es), Smart repair 110,64
