BMW 1: 1FVA284

Limited Technical Inspection

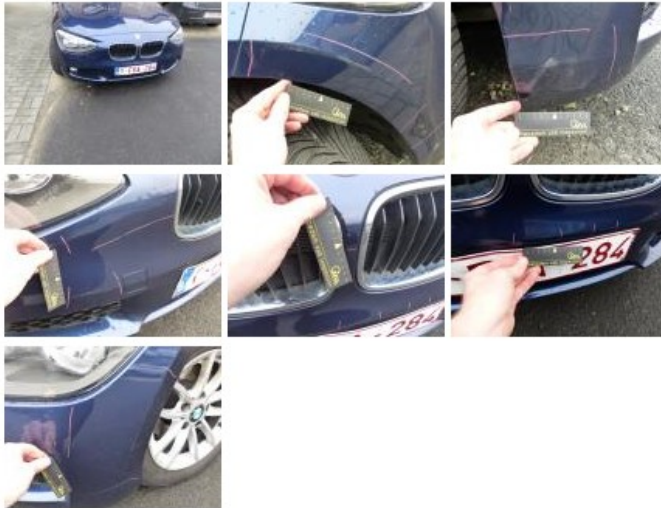
Front bumper, Scratch(es), LI - Repair and paint (complete) 307,80

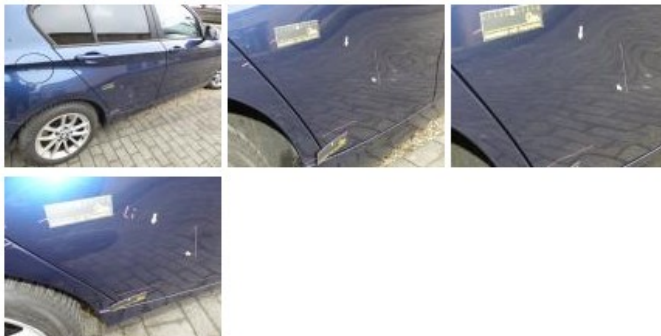
Door R R, Scratch(es), LI - Repair and paint (complete) 438,35

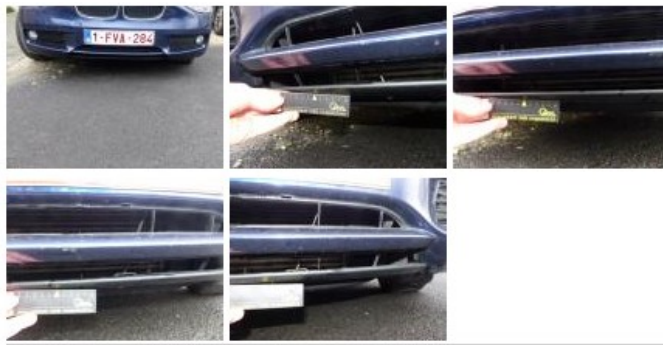
Bumper grille, Broken, E - Replace 32,40

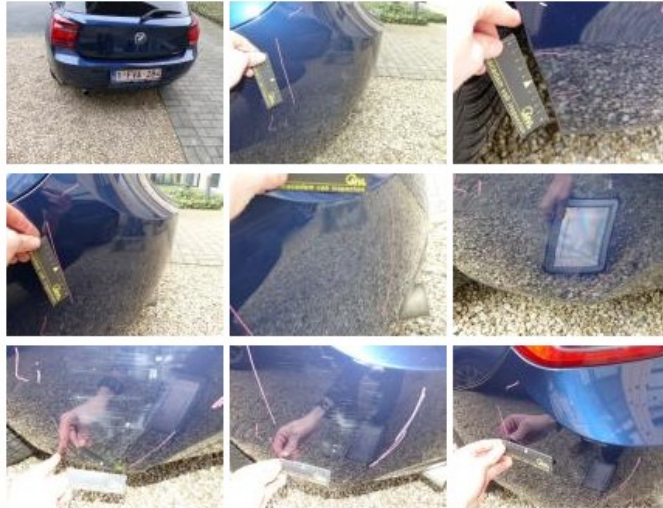
Bumper R, Scratch(es), LI - Repair and paint (complete) 259,80

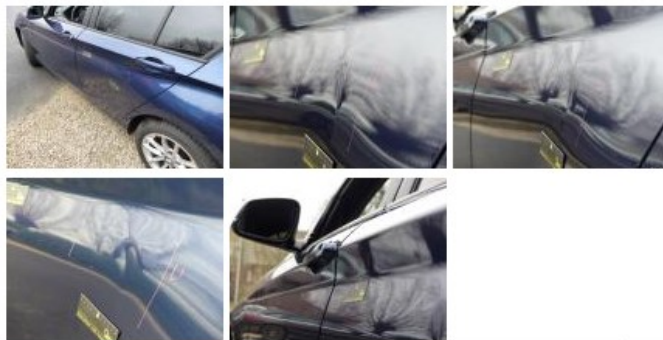
Door R L, Bump(s), LI - Repair and paint (complete) 318,35

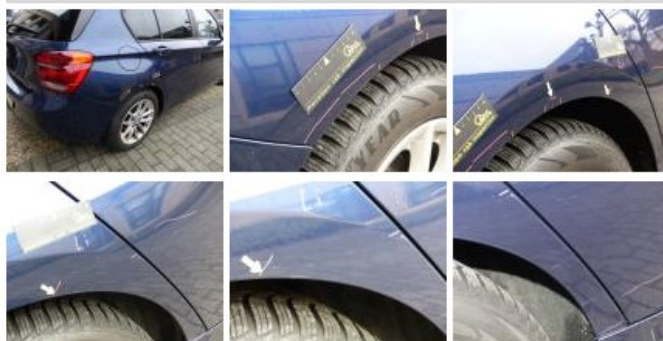
Wing R R, Damaged, LI - Repair and paint (complete) 428,20

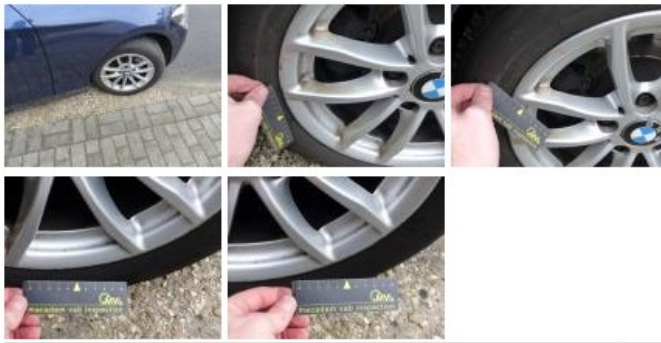
Alloy rim F R, Scratch(es), LI - Repair and paint (complete) 95,00
