<b>BMW 3: 1EGK271</b>			
Vinnumber:	<b>WBA3D91080J411741</b>	Versionname:	<b>3 BER 316d 116PK</b>
First Registrationdate:	<b>26/11/2012</b>	Fiscalpower:	
Expertise Mileage:	<b>154270</b>	Power Kw:	<b>85</b>
Bodytype:		Body color:	<b>Black</b>
Gearbox:	<b>MAN 6 VIT</b>	Paint type:	<b>Metalic</b>
Transmission:		Rims summer:	<b>Aluminium</b>
Fueltype:	<b>Diesel</b>	Oil level:	<b>OK</b>
Battery functioning:	<b>Yes</b>	Parking lot:	<b>1415</b>
Number of doors:	<b>4</b>		
Number of seats:	<b>5</b>		
Number head rests:	<b>5</b>		
Rims summer:	<b>Aluminium</b>		
Category:	<b>Passenger Car</b>		
Oil level:	<b>OK</b>

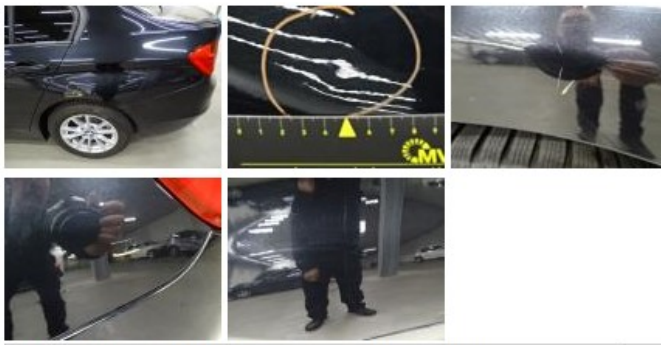
<b>Wing R L, Bump(s) and scratch(es), LI - Repair and paint (complete)</b>	<b>308,20</b>
--	---------------

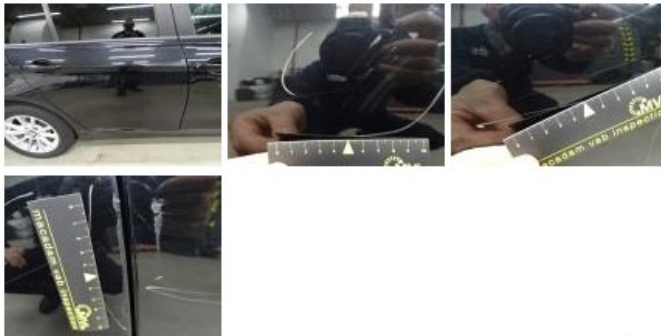
Door R R, Scratch(es), LI - Repair and paint (complete) 318,35

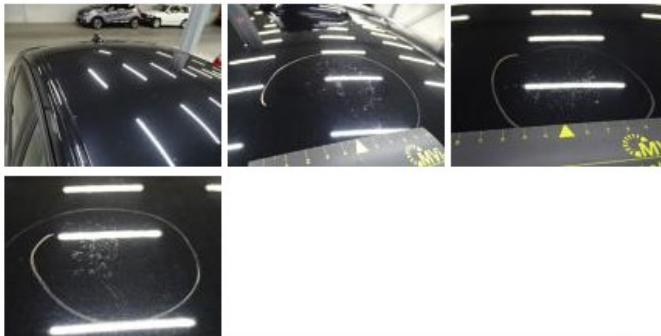
Roof, Chemical polution, LI - Repair and paint (complete) 481,50

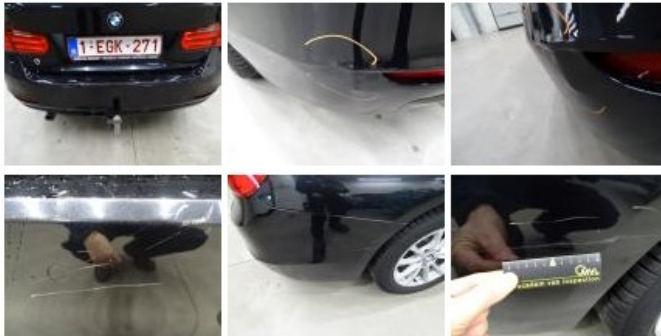
Bumper R, Bump(s) and scratch(es), LI - Repair and paint (complete) 211,80
