**BMW 3: 1CHZ219**

**Limited Technical Inspection**

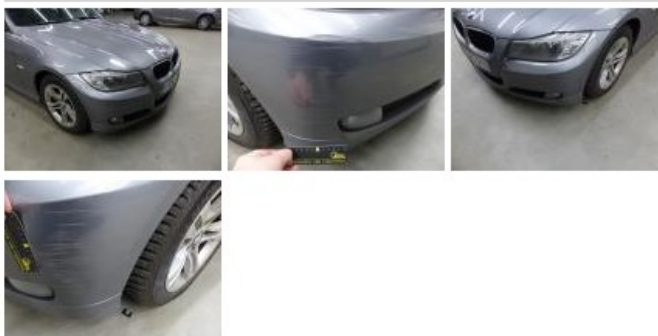
Total cost ex VAT	1767,38
Front bumper, Scratch(es), LI - Repair and paint (complete)	211,80
