<b>BMW 5: 1FLF576</b>			
Vinnumber:	<b>WBA5C31080D045240</b>	Versionname:	<b>5 BER 520d 163PK</b>
First Registrationdate:	<b>5/08/2013</b>	Fiscalpower:	
Expertise Mileage:	<b>162966</b>	Power Kw:	<b>120</b>
Bodytype:		Body color:	<b>Black</b>
Gearbox:	<b>MAN 6 VIT</b>	Paint type:	<b>Metalic</b>
Transmission:	<b>Back</b>	Rims summer:	<b>Aluminium</b>
Fueltype:	<b>Diesel</b>	Oil level:	<b>OK</b>
Battery functioning:	<b>Yes</b>	Parking lot:	<b>2716</b>
Number of doors:	<b>4</b>		
Number of seats:	<b>5</b>		
Number head rests:	<b>5</b>		
Rims summer:	<b>Aluminium</b>		
Category:	<b>Passenger Car</b>		
Oil level:	<b>OK</b>

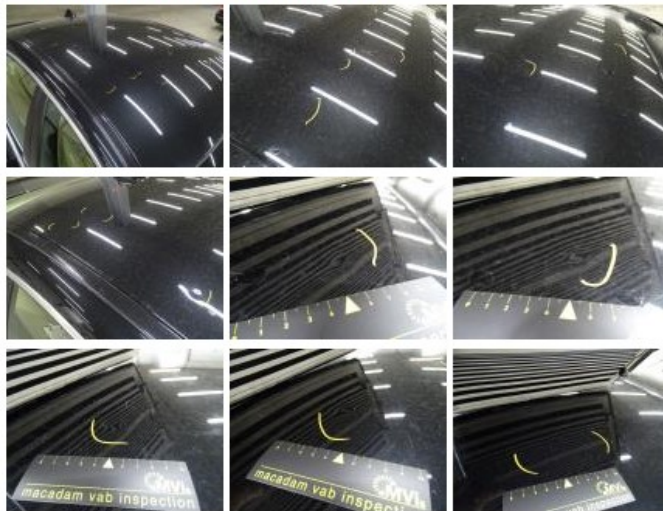
Roof, Bump(s), LI - Repair and paint (complete) 577,80

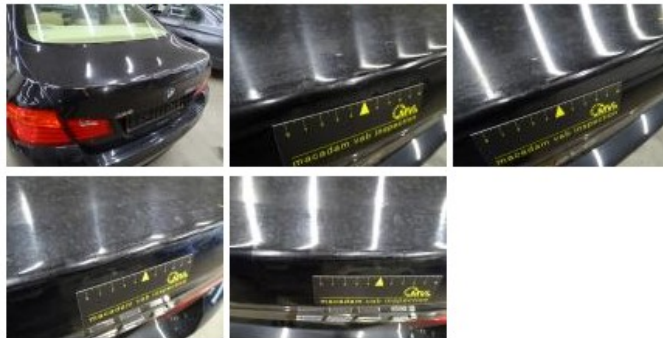
Tailgate, Scratch(es), LI - Repair and paint (complete) 362,02
