<b>PEUGEOT 5008: 1EHW145</b>			
Vinnnumber:	<b>VF30A9HD8CS256075</b>	Versionname:	<b>5008 Allure FAP 115PK</b>
First Registrationdate:	<b>7/12/2012</b>	Fiscalpower:	
Expertise Mileage:	<b>117279</b>	Power Kw:	<b>84</b>
Bodytype:	<b>MPV</b>	Body color:	<b>Black</b>
Gearbox:	<b>MAN 6 VIT</b>	Paint type:	<b>Metalic</b>
Transmission:	<b>Front</b>	Rims summer:	<b>Aluminium</b>
Fueltype:	<b>Diesel</b>	Oil level:	<b>OK</b>
Battery functioning:	<b>Yes</b>	Parking lot:	<b>2105</b>
Number of doors:	<b>5</b>		
Number of seats:	<b>5</b>		
Number head rests:	<b>5</b>		
Rims summer:	<b>Aluminium</b>		
Category:	<b>Passenger Car</b>		
Oil level:	<b>OK</b>

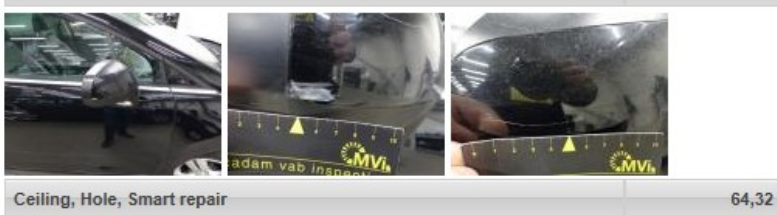
<b>Assistance equipment</b>			
Repair kit	<b>Yes</b>	Compressor	<b>Yes</b>
<b>Total cost ex VAT</b>			<b>1720,09</b>
<b>Rearview mirror housing R, Scratch(es), LI - Repair and paint (complete)</b>			<b>115,56</b>

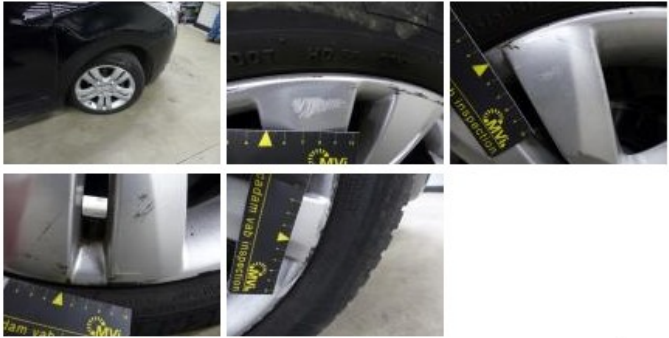
Bumper F R, Scratch(es), Acceptable	0,00
<i>No pictures to display</i>	
Alloy rim F R, Scratch(es), LI - Repair and paint (complete)	95,00
