## MINI Mini: 1FRP201

## Limited Technical Inspection

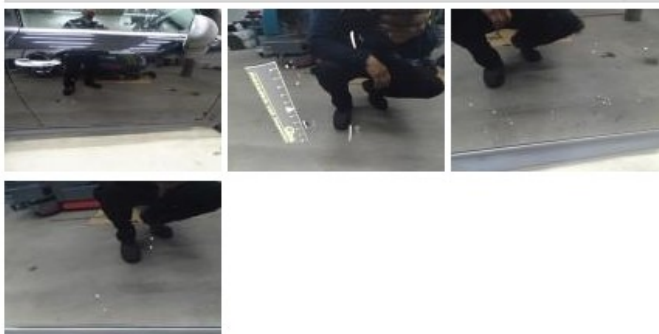
Total cost ex VAT	1806,40
Door F R, Scratch(es), LI - Repair and paint (complete)	318,35
