SKODA Octavia: 1EDF538			
Vinnumber:	TMBHT21ZXC2072075	Versionname:	OCTAVIA COMBI GTec Ambition DPF 105PK
First Registrationdate:	25/10/2012	Fiscalpower:	
Expertise Mileage:	212379	Power Kw:	77
Bodytype:	Break	Body color:	Grey
Gearbox:	MAN 6 VIT	Paint type:	Metalic
Transmission:		Rims summer:	Aluminium
Fueltype:	Diesel	Oil level:	OK
Battery functioning:	Yes	Parking lot:	2332
Number of doors:	5		
Number of seats:	5		
Number head rests:	5		
Rims summer:	Aluminium		
Category:	Passenger Car		
Oil level:	OK

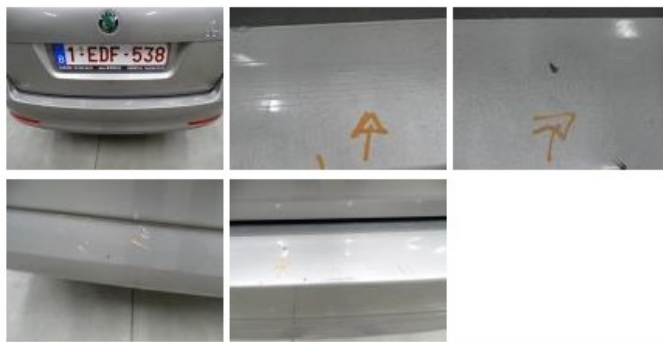
Bumper R, Bump(s) and scratch(es), LI - Repair and paint (complete)	211,80
---	--------

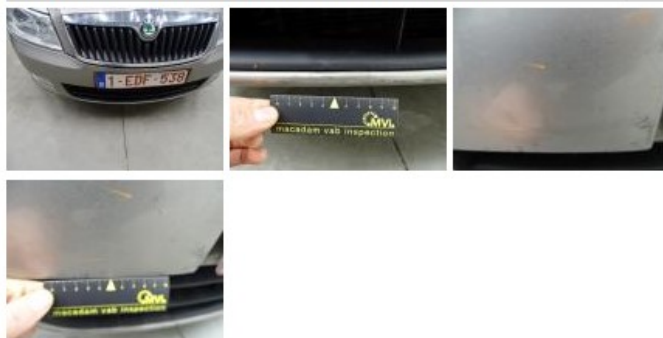
Front bumper, Scratch(es), LI - Repair and paint (complete) 211,80

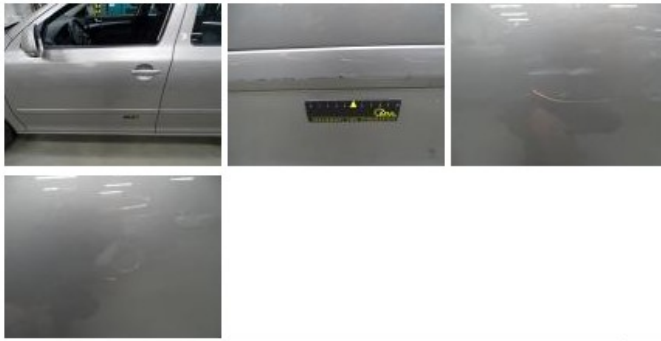
Door F L, Scratch(es), LI - Repair and paint (complete) 318,35

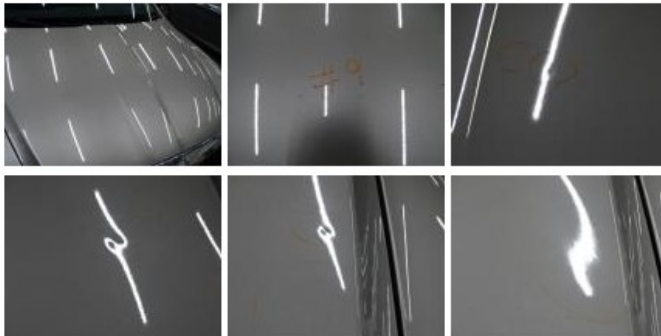
Bonnet, Bump(s), LI - Repair and paint (complete) 290,08
