**SKODA Octavia: 1BOP794**

**Limited Technical Inspection**

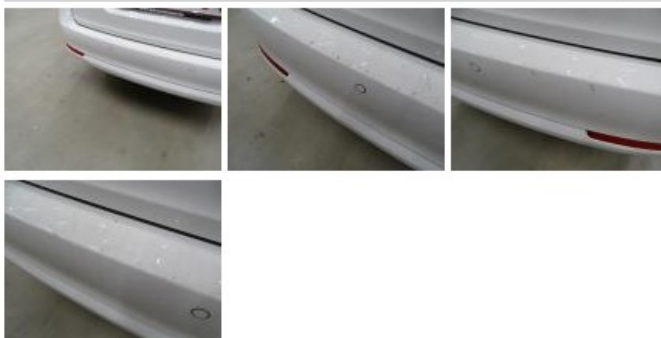
<b>Total cost ex VAT</b>	<b>1060,30</b>
<b>Bumper R, Scratch(es), LI - Repair and paint (complete)</b>	<b>211,80</b>

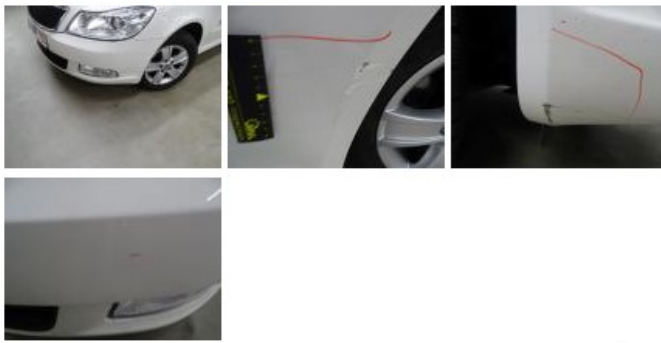
<b>Front bumper, Scratch(es), LI - Repair and paint (complete)</b>	<b>211,80</b>
--	---------------
