## VOLVO V60: 1GPD983

## Limited Technical Inspection

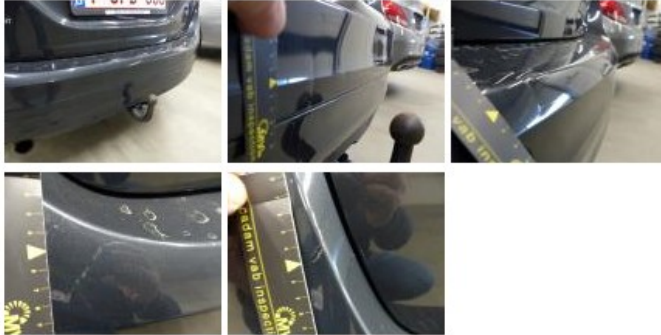
Bumper R, Bump(s) and scratch(es), LI - Repair and paint (complete)	283,80
---	--------
