## VOLVO V60: 1FNT362

## Limited Technical Inspection

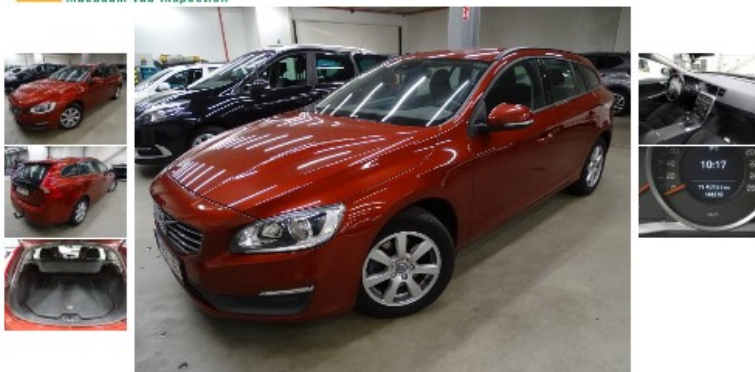
Alloy rim R L, Scratch(es), LI - Repair and paint (complete)	95,00
--	-------
