## VOLKSWAGEN PASSAT: 1GDK194

## Limited Technical Inspection

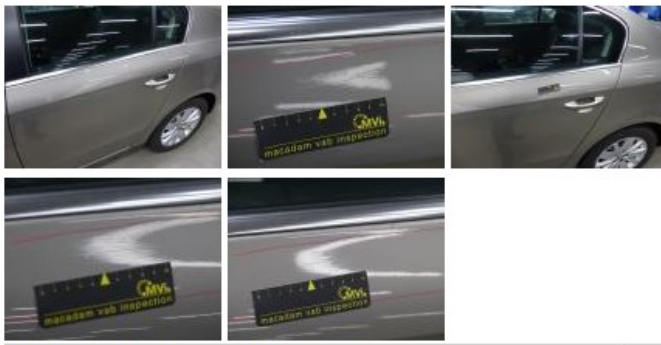
Alloy rim R R, Scratch(es), Acceptable	0,00
No pictures to display	
Door R L, Bad repair, Paint	0,00

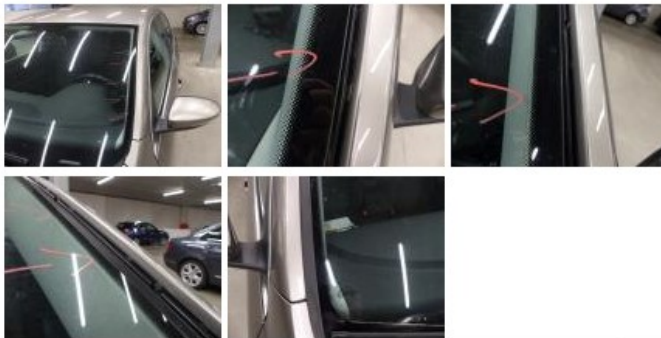
Moulding windscreen L, Missing, E - Replace 32,00
