BMW 5: 1GC595			
Vinnumber:	WBA5J11000D335854	Versionname:	5 TOURING 518d 136PK
First Registrationdate:	2/01/2014	Fiscalpower:	
Expertise Mileage:	127262	Power Kw:	100
Bodytype:	Break	Body color:	Dark Brown
Gearbox:	MAN 6 VIT	Paint type:	Metalic
Transmission:	Back	Rims summer:	Aluminium
Fueltype:	Diesel	Oil level:	OK
Battery functioning:	Yes	Parking lot:	3202
Number of doors:	5		
Number of seats:	5		
Number head rests:	5		
Rims summer:	Aluminium		
Category:	Passenger Car		
Oil level:	OK		
Registration Certificate Car (BE):	Yes

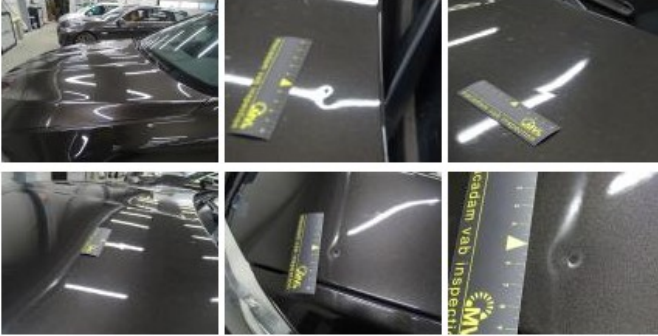
Bonnet, Bump(s), LI - Repair and paint (complete) 348,09
