PEUGEOT Boxer 335: 1DXG834

Limited Technical Inspection

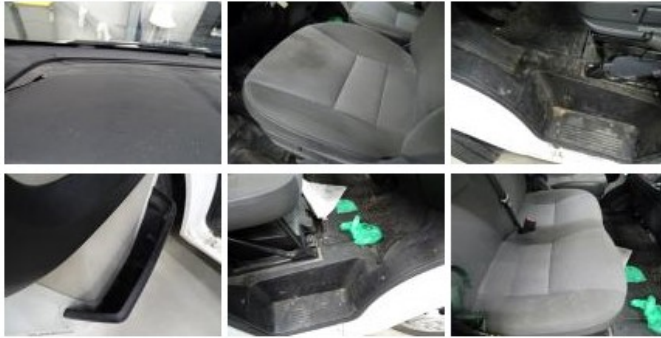
Interior, Dirty, Cleaning 100,00
