**MERCEDES C- CLASSE: 1FRK081**

**Limited Technical Inspection**

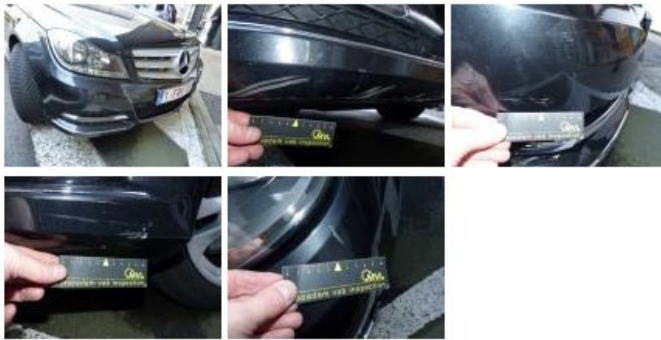
Rearview mirror housing R, Scratch(es), Acceptable	0,00
<i>No pictures to display</i>	
Door F L, Scratch(es), Acceptable	0,00
<i>No pictures to display</i>	
Door panel F L, Burned, Acceptable	0,00
<i>No pictures to display</i>	
Wing R L, Scratch(es), Acceptable	0,00
<i>No pictures to display</i>	
Alloy rim R L, Scratch(es), Acceptable	0,00
<i>No pictures to display</i>	
Alloy rim R R, Scratch(es), Acceptable	0,00
<i>No pictures to display</i>	
Front bumper, Scratch(es), LI - Repair and paint (complete)	211,80

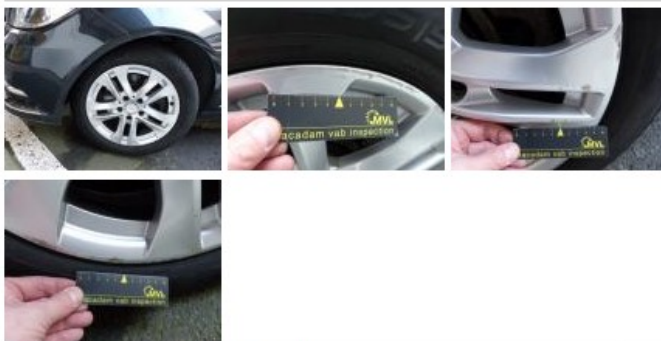
Door F R, Scratch(es), Acceptable	0,00
<i>No pictures to display</i>	
Rearview mirror housing L, Scratch(es), Acceptable	0,00
<i>No pictures to display</i>	
Alloy rim F L, Scratch(es), LI - Repair and paint (complete)	95,00

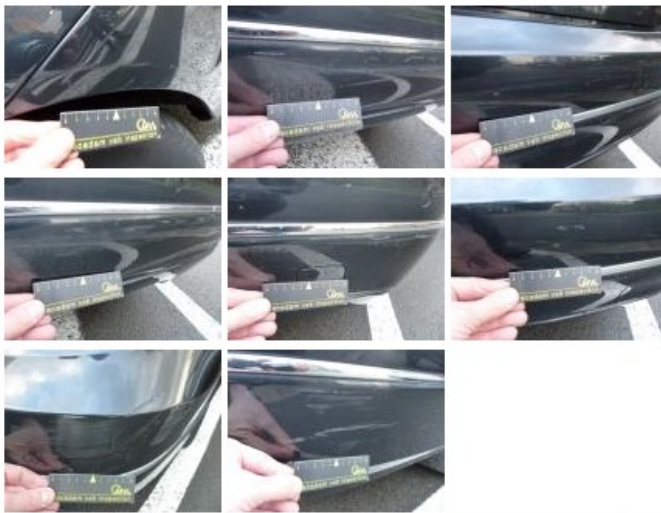
Bumper R, Bump(s) and scratch(es), Le - Replace and paint	651,00
---	--------

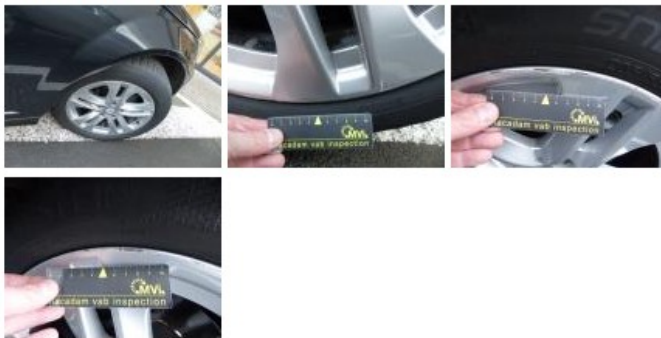
Alloy rim F R, Scratch(es), LI - Repair and paint (complete) 95,00

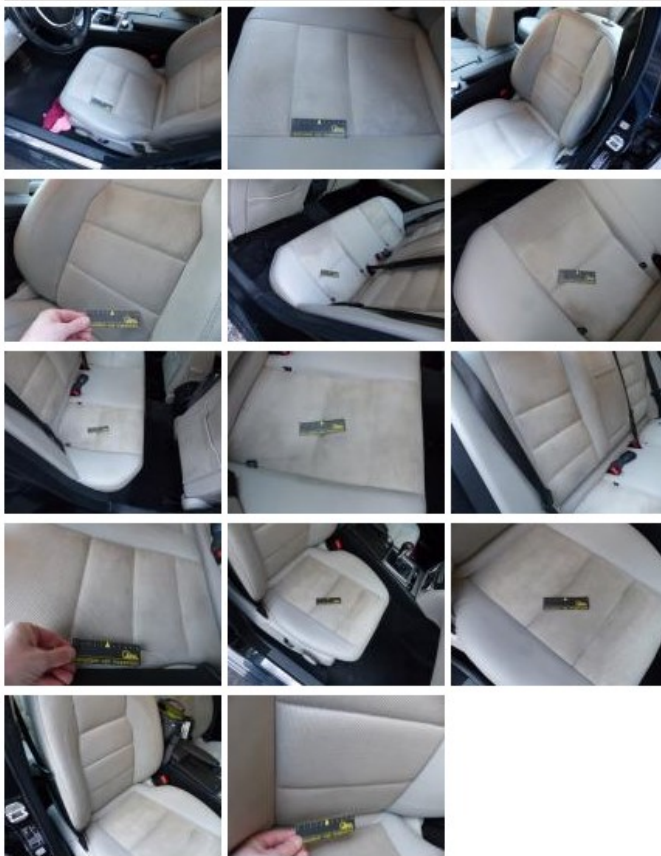
Interior, Dirty, Cleaning 100,00
