MERCEDDES C: 1ENF787			
Vinnnumber:	WDD2042001G069779	Versionname:	C BRE 180 CDI BlueEFF. S&S 120PK
First Registrationdate:	29/01/2013	Fiscalpower:	
Expertise Mileage:	169844	Power Kw:	88
Bodytype:	Break	Body color:	Black
Gearbox:	Automatic	Paint type:	Metalic
Transmission:		Rims summer:	Aluminium
Fueltype:	Diesel	Oil level:	OK
Battery functioning:	Yes	Parking lot:	1425
Number of doors:	5		
Number of seats:	5		
Number head rests:	5		
Rims summer:	Aluminium		
Category:	Passenger Car		
Oil level:	OK

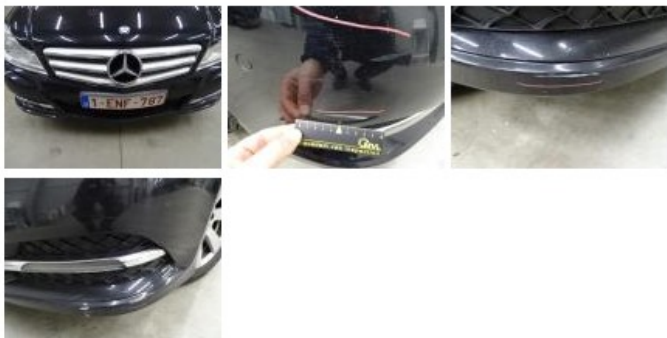
Assistance equipment	
Total cost ex VAT	2465,73
Front bumper, Scratch(es), LI - Repair and paint (complete)	211,80

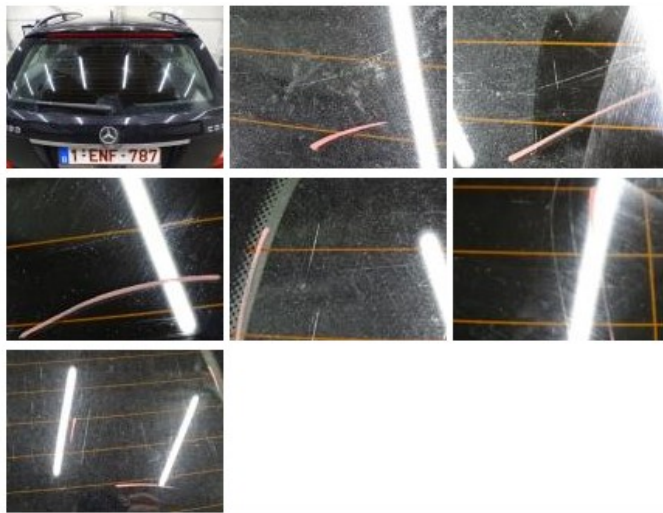
Wing F L, Chemical polution, Acceptable	0,00
<i>No pictures to display</i>	
Rear window, Scratch(es), E - Replace	370,00

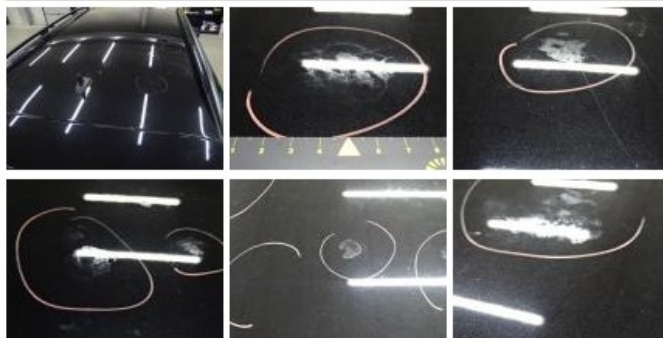
Roof, Chemical pollution, LI - Repair and paint (complete) 481,50
