| MERCEDES B: 1GQE997 | | | |
| Vinnumber: | WDD2462011J244014 | Versionname: | B 200 CDI BE 136PK |

| Limited Technical Inspection | | | |

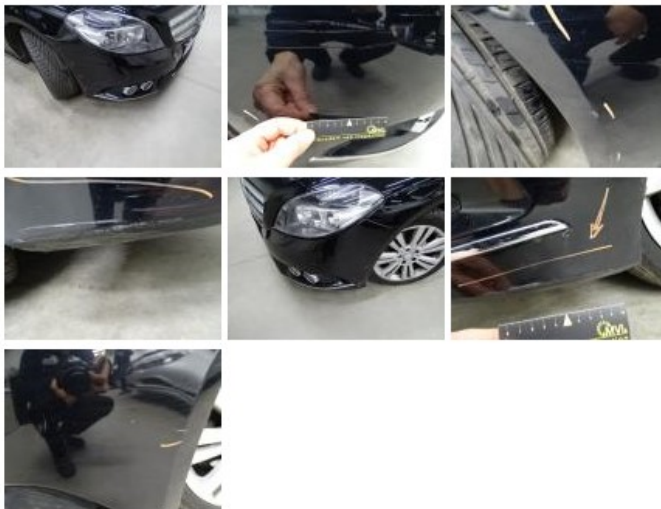
Front bumper, Scratch(es), LI - Repair and paint (complete) 211,80
