VOLVO V40: 1EMF057

Limited Technical Inspection

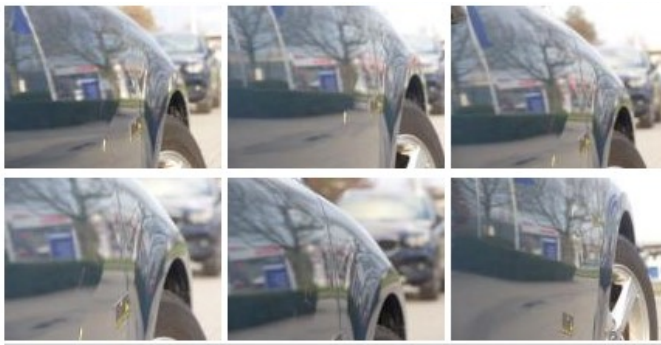
Total cost ex VAT	1277,94
Alloy rim F R, Scratch(es), Acceptable	0,00
<i>No pictures to display</i>	
Bumper grille, Bump(s), Acceptable	0,00
<i>No pictures to display</i>	
Bonnet, Stone chip(s), Acceptable	0,00
<i>No pictures to display</i>	
Door F R, Damaged, LI - Repair and paint (complete)	414,35

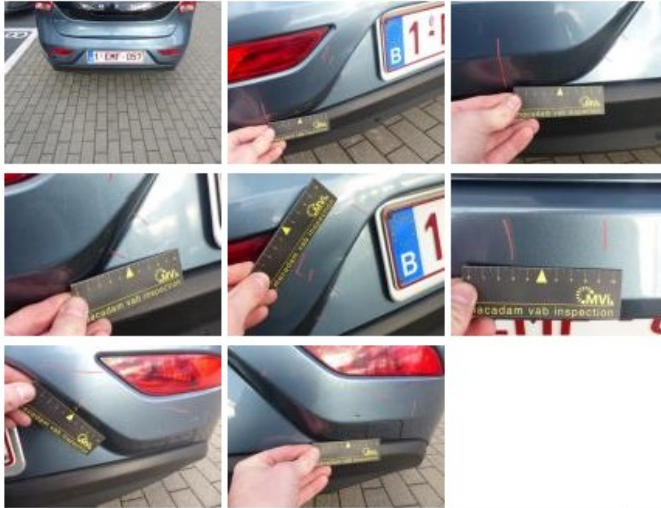
Bumper R, Damaged, LI - Repair and paint (complete) 259,80

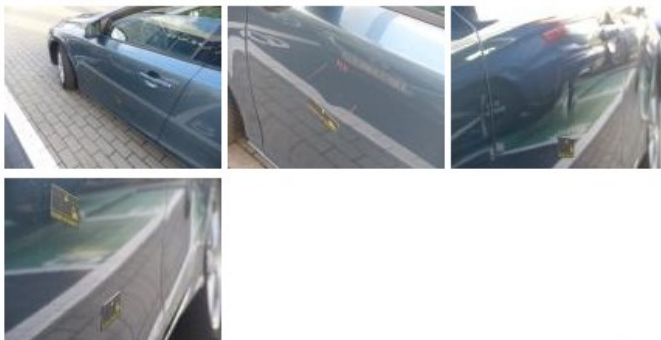
Door F L, Bump(s), PDR - Knock out without painting 82,80

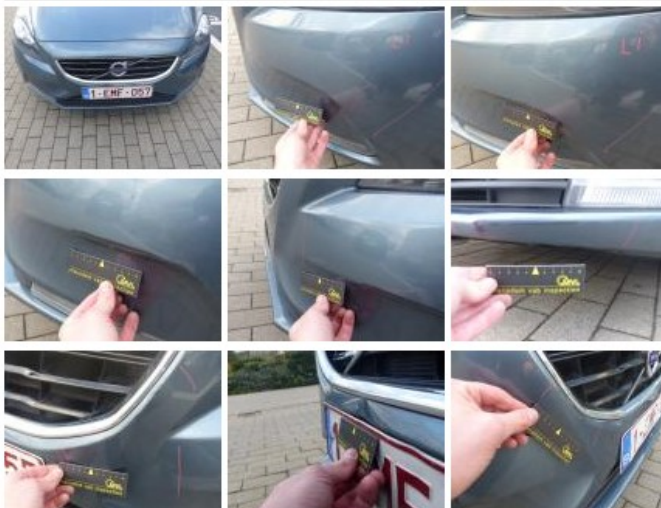
Front bumper, Bump(s) and scratch(es), LI - Repair and paint (complete) 307,80
