**BMW 1: 1GBG515**

**Limited Technical Inspection**

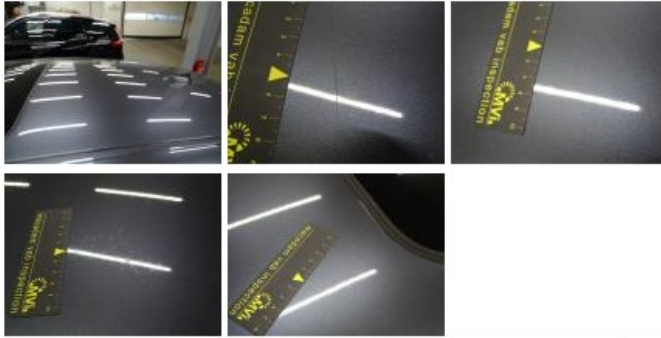
Roof, Bump(s), LI - Repair and paint (complete) 481,50
