BMW 5: 1HUP176

Vinnumber:	WBA5E310X0D672581	Versionname:	5 BER 518d 136PK
First Registrationdate:	7/10/2014	Fiscalpower:	
Expertise Mileage:	178916	Power Kw:	100
Bodytype:		Body color:	Black
Gearbox:	MAN 6 VIT	Paint type:	Metalic
Transmission:	Back	Rims summer:	Aluminium
Fueltype:	Diesel	Oil level:	OK
Maintenance:	OK	Parking lot:	2405
Maintenance:	AUGUSTUS 2019		
Maintenance:	5000		
Battery functioning:	Yes		
Number of doors:	4		
Number of seats:	5		
Number head rests:	5		
Rims summer:	Aluminium		
Category:	Passenger Car		
Oil level:	OK		
Registration Certificate Car (BE):	Yes

Limited Technical Inspection

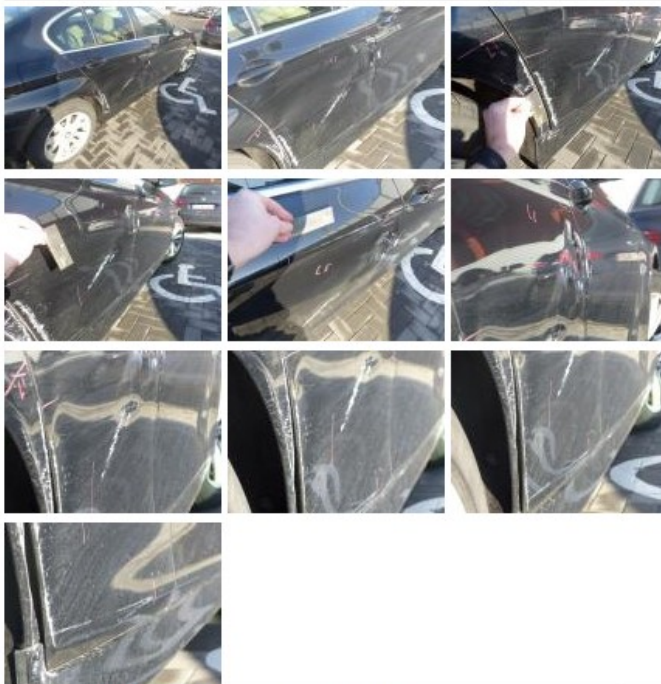
Door R R, Damaged, Le - Replace and paint 0,00

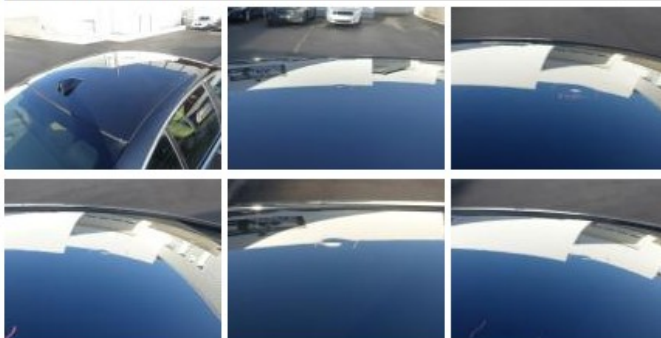
Roof, Bump(s), PDR - Knock out without painting 142,20

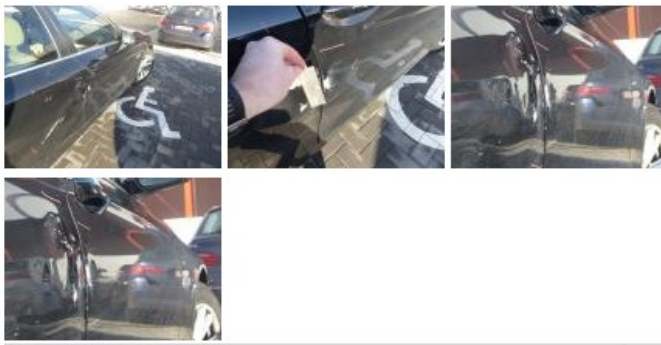
Door F R, Bump(s) and scratch(es), LI - Repair and paint (complete) 0,00

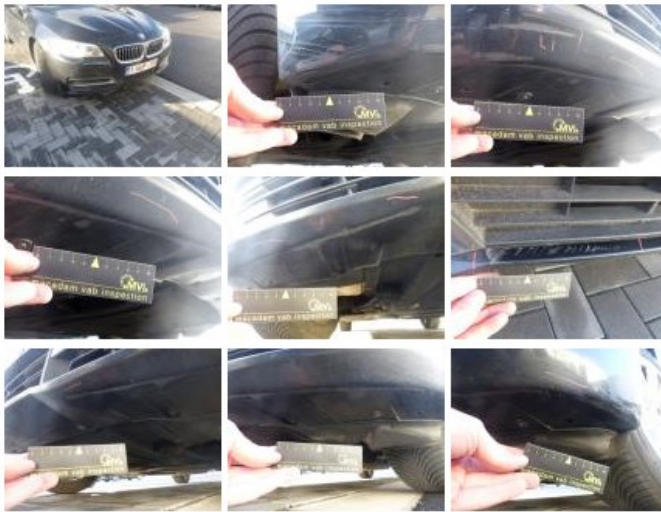
Front bumper, Scratch(es), LI - Repair and paint (complete) 302,16

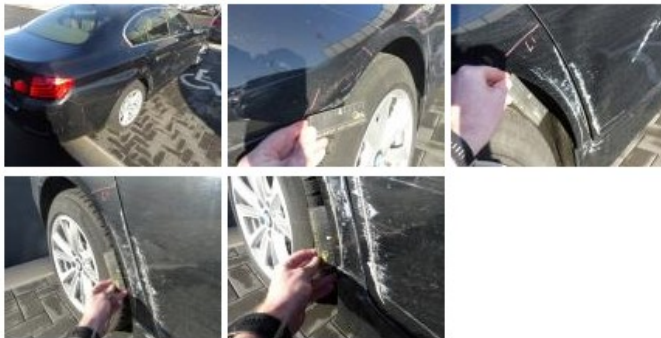
Wing R R, Damaged, LI - Repair and paint (complete) 0,00
