**BMW 3: 1FSQ328**

**Limited Technical Inspection**

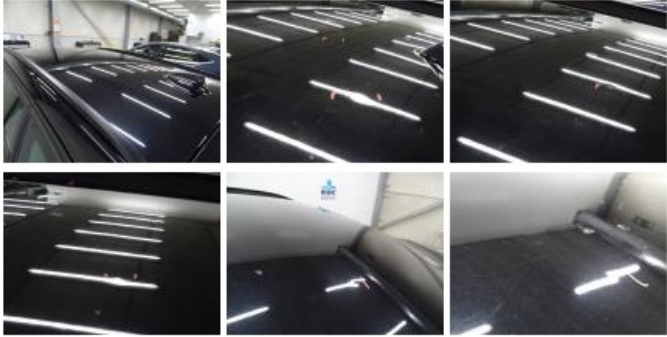
<i>No pictures to display</i>	
Rearview mirror housing R, Scratch(es), Acceptable	0,00
<i>No pictures to display</i>	
Alloy rim R L, Scratch(es), Acceptable	0,00
<i>No pictures to display</i>	
Door R R, Scratch(es), Acceptable	0,00
<i>No pictures to display</i>	
Wing R R, Scratch(es), Acceptable	0,00
<i>No pictures to display</i>	
Bodywork, Hail damage, PDR - Hail	58,80
