<b>FORD Mondeo: 1FNJ649</b>			
Vinnnumber:	<b>WF0EXXGBBEB27368</b>	Versionname:	<b>MONDEO BER ECONetic Trend Style 115PK</b>
First Registrationdate:	<b>28/08/2013</b>	Fiscalpower:	
Expertise Mileage:	<b>63257</b>	Power Kw:	<b>85</b>
Bodytype:		Body color:	<b>Black</b>
Gearbox:	<b>MAN 6 VIT</b>	Paint type:	<b>Metalic</b>
Transmission:	<b>Front</b>	Rims summer:	<b>Aluminium</b>
Fueltype:	<b>Diesel</b>	Oil level:	<b>OK</b>
Battery functioning:	<b>Yes</b>	Parking lot:	<b>3208</b>
Number of doors:	<b>5</b>		
Number of seats:	<b>5</b>		
Number head rests:	<b>5</b>		
Rims summer:	<b>Aluminium</b>		
Category:	<b>Passenger Car</b>		
Oil level:	<b>OK</b>

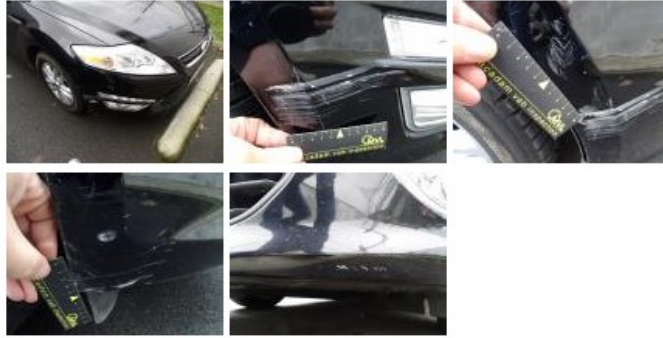
Rear spoiler, Scratch(es), Acceptable	0,00
<i>No pictures to display</i>	
Boot carpet, Stain, Acceptable	0,00
<i>No pictures to display</i>	
Door F L, Bump(s) and scratch(es), Acceptable	0,00
<i>No pictures to display</i>	
Front bumper, Scratch(es), LI - Repair and paint (complete)	211,80
