MERCEDÉS A: 1HZL660			
Vinnnumber:	WDD1760121V039300	Versionname:	A 180 CDI BE 109PK
First Registrationdate:	6/11/2014	Fiscalpower:	
Expertise Mileage:	105967	Power Kw:	80
Bodytype:		Body color	Black
Gearbox:	MAN 6 VIT	Paint type	Metalic
Transmission:		Rims summer	Aluminium
Fueltype:	Diesel	Oil level	OK
Battery functioning	Yes	Parking lot	1124
Number of doors	5		
Number of seats	5		
Number head rests	5		
Rims summer	Aluminium		
Category	Passenger Car		
Oil level	OK		
Registration Certificate Car (BE)	Yes

MVI
macadam vab inspection

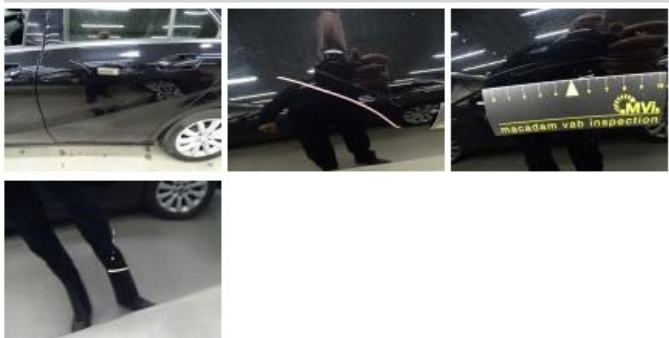
Total cost ex VAT	995,15
Bumper R, Scratch(es), Acceptable	0,00
<i>No pictures to display</i>	
Door R L, Scratch(es), LI - Repair and paint (complete)	318,35
