**BMW 518D: 1GCY520**

**Limited Technical Inspection**

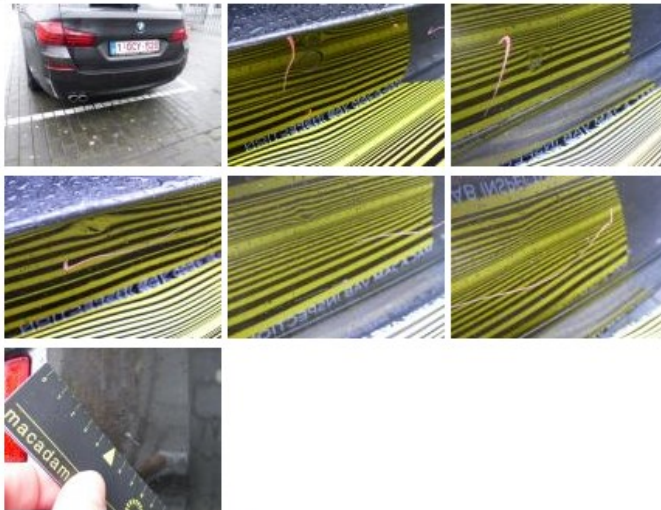
Bumper R, Bump(s) and scratch(es), LI - Repair and paint (complete) 302,16
