AUDI A5: 1FLF671			
Vinnnumber:	<b>WAUZZZ8TXEA013854</b>	Versionname:	<b>A5 SB DPF Multitr. 136PK Aut.</b>
First Registrationdate:	<b>5/08/2013</b>	Fiscalpower:	
Expertise Mileage:	<b>57672</b>	Power Kw:	<b>100</b>
Bodytype:	<b>Hatchback</b>	Body color:	<b>Blue</b>
Gearbox:	<b>Automatic</b>	Paint type:	<b>Metalic</b>
Transmission:	<b>Front</b>	Rims summer:	<b>Aluminium</b>
Fueltype:	<b>Diesel</b>	Oil level:	<b>OK</b>
Battery functioning:	<b>Yes</b>	Parking lot:	<b>4829</b>
Number of doors:	<b>5</b>		
Number of seats:	<b>4</b>		
Number head rests:	<b>4</b>		
Rims summer:	<b>Aluminium</b>		
Category:	<b>Passenger Car</b>		
Oil level:	<b>OK</b>

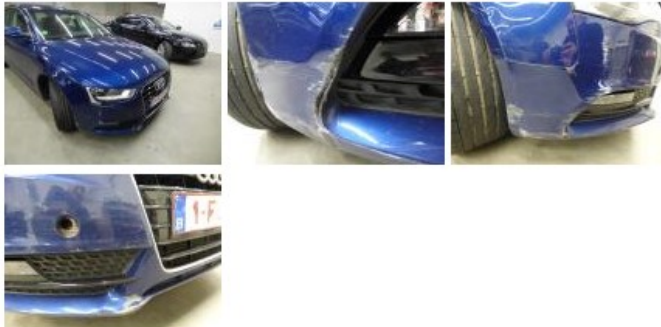
Front bumper, Crack, Le - Replace and paint 0,00

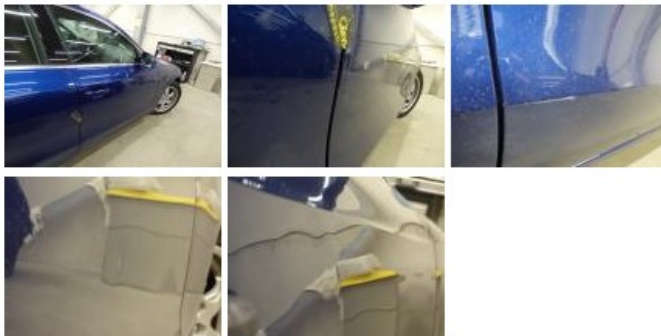
Door F R, Bump(s), LI - Repair and paint (complete) 430,02
