**BMW 3: 1EPK816**

**Limited Technical Inspection**

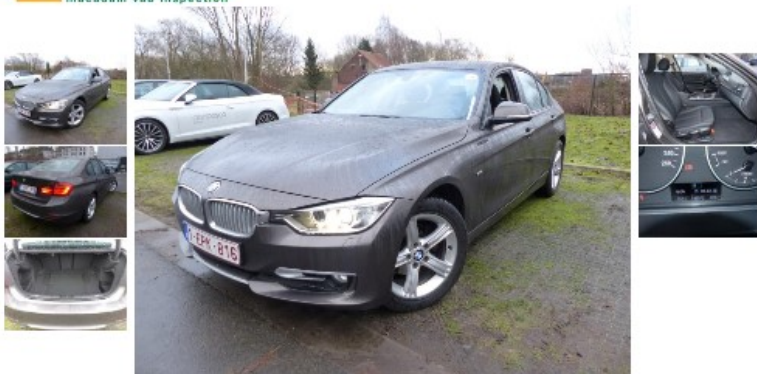
Total cost ex VAT	<b>115,56</b>
Bumper R, Bump(s), It - Spot repair	<b>115,56</b>
