**FORD S Max: 1DWY128**

**Limited Technical Inspection**

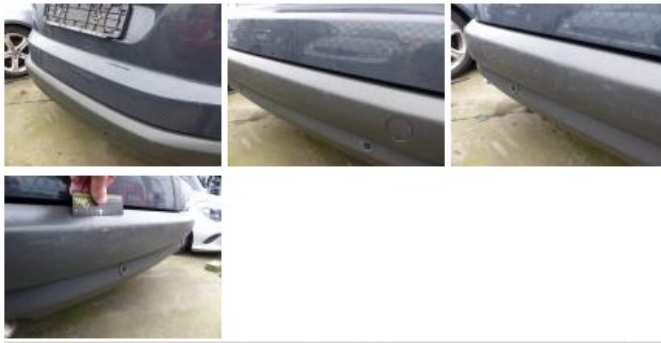
Bumper R, Scratch(es), LI - Repair and paint (complete) 254,16
