**OPEL Insignia: 1ELB267**

**Limited Technical Inspection**

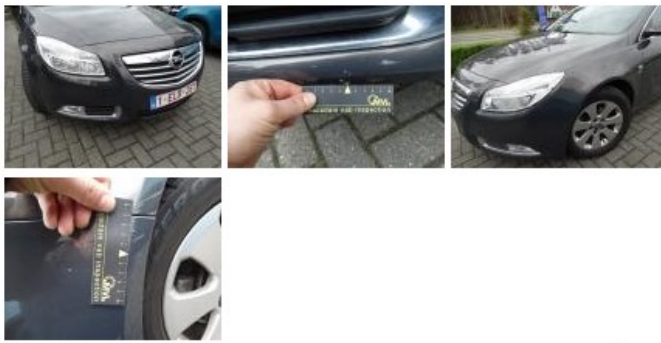
Front bumper, Scratch(es), LI - Repair and paint (complete)	211,80
---	--------
