SKODA Octavia: 1GHC949

| Vinnumber: | TMBAC9NE5E0147619 | Versionname: | OCTAVIA BER Ambition |

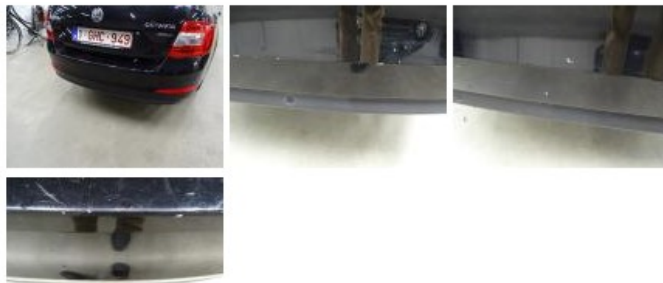
| Bumper R, Scratch(es), LI - Repair and paint (complete) | 211,80 |

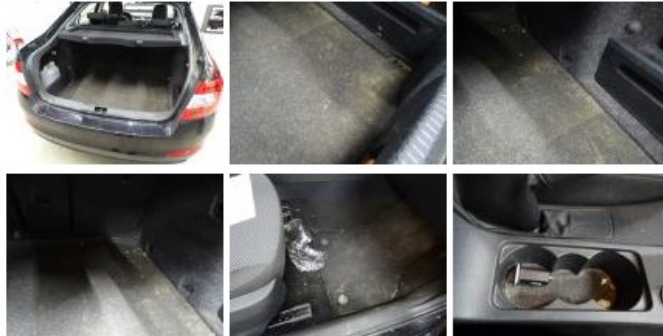
Interior, Dirty, Cleaning 100,00
