SKODA Fabia BREAK: 1DXH706

Limited Technical Inspection

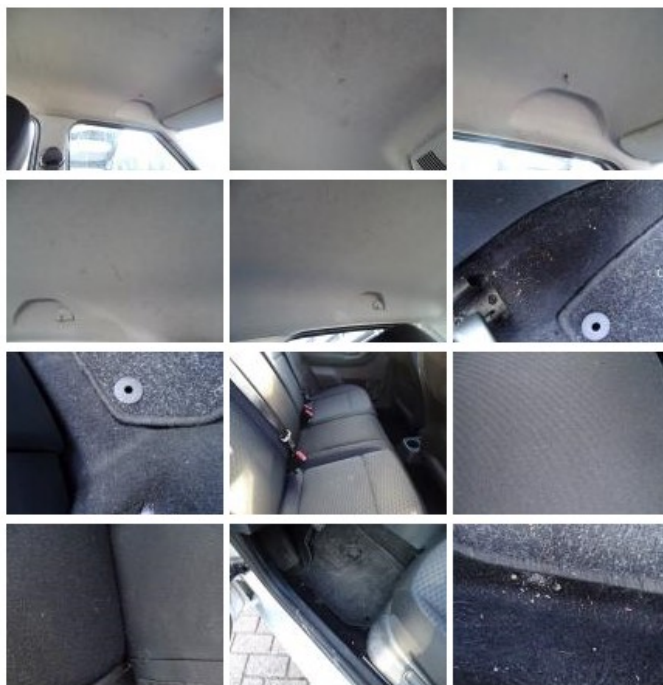
Repair kit	Yes	Compressor	Yes
Total cost ex VAT			991,74
Door R L, Scratch(es), Acceptable			0,00
<i>No pictures to display</i>			
Trunk lid covering R, Scratch(es), Acceptable			0,00
<i>No pictures to display</i>			
Alloy rim F L, Scratch(es), Acceptable			0,00
<i>No pictures to display</i>			
Windscreen, Stone chip(s), Acceptable			0,00
<i>No pictures to display</i>			
Door F L, Bump(s), Acceptable			0,00
<i>No pictures to display</i>			
Roof, Scratch(es), Acceptable			0,00
<i>No pictures to display</i>			
Interior, Dirty, Cleaning			100,00
