BMW 3: QA8434

Limited Technical Inspection

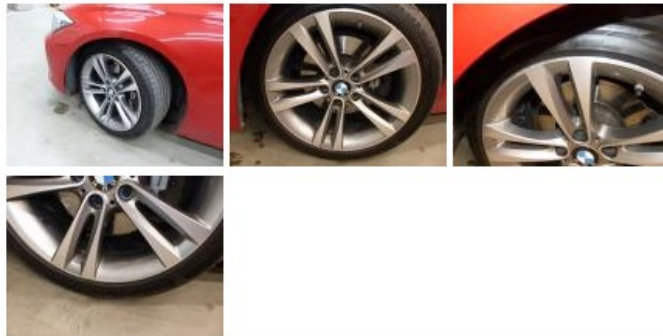
Alloy rim F L polished, Scratch(es), LI - Repair and paint (complete) 95,00
