BMW SERIE 3 GRAN TURISMO: 1GCV584			
Vinnumber:	<b>WBA3Y11020D448126</b>	Versionname:	<b>318d</b>
First Registrationdate:	<b>3/01/2014</b>	Fiscalpower:	
Expertise Mileage:	<b>151018</b>	Power Kw:	<b>100</b>
Bodytype:		Body color:	<b>Blue</b>
Gearbox:	<b>MAN 6 VIT</b>	Paint type:	<b>Metalic</b>
Transmission:	<b>Back</b>	Rims summer:	<b>Aluminium</b>
Fueltype:	<b>Diesel</b>	Oil level:	<b>OK</b>
Battery functioning:	<b>Yes</b>	Parking lot:	<b>2626</b>
Number of doors:	<b>5</b>		
Number of seats:	<b>5</b>		
Number head rests:	<b>5</b>		
Rims summer:	<b>Aluminium</b>		
Category:	<b>Passenger Car</b>		
Oil level:	<b>OK</b>		
Registration Certificate Car (BE):	<b>Yes</b>

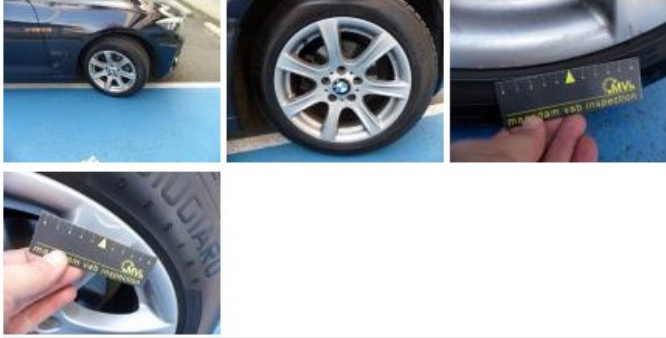
Wing F L, Bump(s), Acceptable		0,00
<i>No pictures to display</i>		
Alloy rim F R, Scratch(es), LI - Repair and paint (complete)		95,00
