FORD S-Max: 1FRG395

Vinnumber:	WF0SXXGBWSDC65423	Versionname:	TDCI
First Registrationdate:	1/10/2013	Fiscalpower:	
Expertise Mileage:	147016	Power Kw:	85
Bodytype:		Body color:	Grey
Gearbox:	MAN 6 VIT	Paint type:	Metalic
Transmission:	Front	Rims summer:	Aluminium
Fueltype:	Diesel	Oil level:	OK
Battery functioning:	Yes	Parking lot:	1104
Number of doors:	5		
Number of seats:	7		
Number head rests:	7		
Rims summer:	Aluminium		
Category:	Passenger Car		
Oil level:	OK		
Registration Certificate Car (BE):	Yes

Limited Technical Inspection

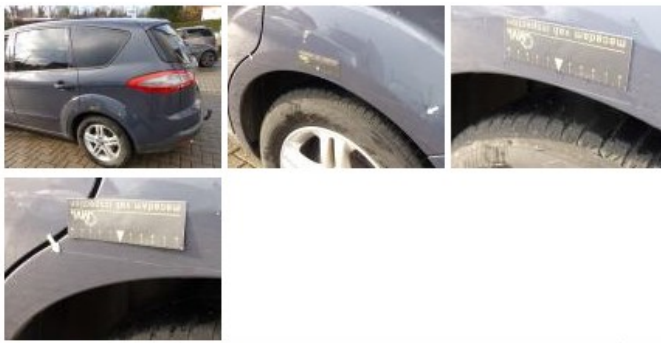
Repair kit	Yes	Compressor	Yes
Total cost ex VAT			972,64
Bumper corner R R, Scratch(es), Acceptable			0,00
<i>No pictures to display</i>			
Trunk lid covering R, Scratch(es), Acceptable			0,00
<i>No pictures to display</i>			
Internal Boot Lining L, Scratch(es), Acceptable			0,00
<i>No pictures to display</i>			
Wing R L, Scratch(es), LI - Repair and paint (complete)			369,84

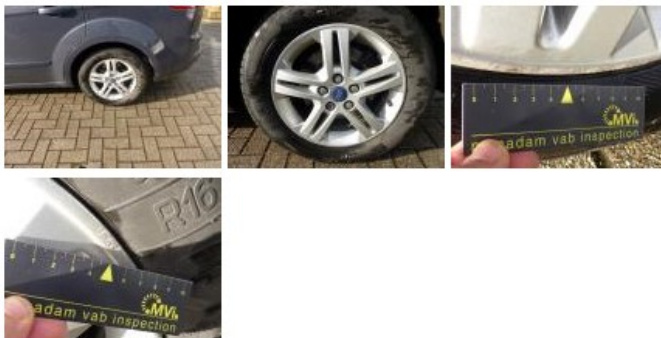
Door R R, Bump(s), Acceptable	0,00
<i>No pictures to display</i>	
Alloy rim F L, Scratch(es), Acceptable	0,00
<i>No pictures to display</i>	
Door R L, Scratch(es), Acceptable	0,00
<i>No pictures to display</i>	
Alloy rim R L, Scratch(es), LI - Repair and paint (complete)	95,00

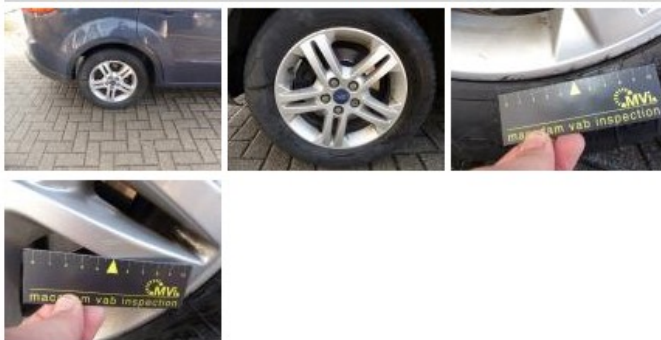
Alloy rim R R, Scratch(es), LI - Repair and paint (complete)	95,00
--	-------
