MERCEDES A: 1EOE302			
Vinnumber:	<b>WDD1760121J060577</b>	Versionname:	<b>A 180 CDI BE 109PK</b>
First Registrationdate:	<b>5/02/2013</b>	Fiscalpower:	
Expertise Mileage:	<b>148159</b>	Power Kw:	<b>80</b>
Bodytype:		Body color:	<b>Grey</b>
Gearbox:	<b>MAN 6 VIT</b>	Paint type:	<b>Metalic</b>
Transmission:		Rims summer:	<b>Aluminium</b>
Fueltype:	<b>Diesel</b>	Oil level:	<b>OK</b>
Battery functioning:	<b>Yes</b>	Parking lot:	<b>1304</b>
Number of doors:	<b>4</b>		
Number of seats:	<b>5</b>		
Number head rests:	<b>5</b>		
Rims summer:	<b>Aluminium</b>		
Category:	<b>Passenger Car</b>		
Oil level:	<b>OK</b>

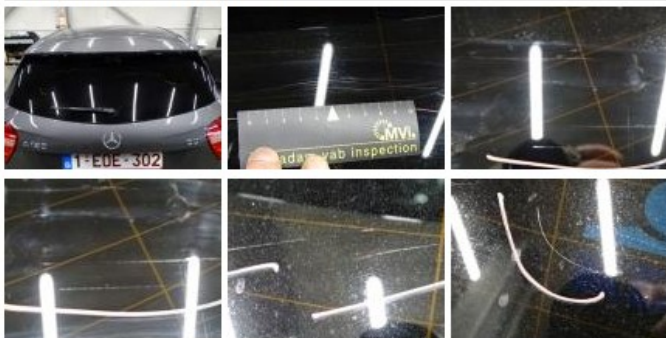
Total cost ex VAT	<b>521,80</b>
Door F R, Scratch(es), Acceptable	<b>0,00</b>
<i>No pictures to display</i>	
Rear window, Scratch(es), E - Replace	<b>0,00</b>

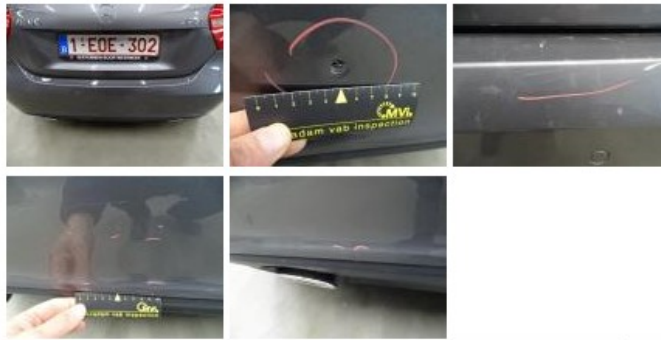
Bumper R, Bump(s) and scratch(es), LI - Repair and paint (complete) 211,80
