SKODA Superb: 1DWT815			
Vinnnumber:	<b>TMBJJ73T0D9019665</b>	Versionname:	<b>SUPERB COMBI GreenLin.Ambition DPF 105PK</b>
First Registrationdate:	<b>20/09/2012</b>	Fiscalpower:	<b>77</b>
Expertise Mileage:	<b>158659</b>	Power Kw:	<b>77</b>
Bodytype:		Body color:	<b>Black</b>
Gearbox:	<b>MAN 5 VIT</b>	Paint type:	<b>Metalic</b>
Transmission:	<b>Front</b>	Rims summer:	<b>Aluminium</b>
Fueltype:	<b>Diesel</b>	Oil level:	<b>OK</b>
Battery functioning:	<b>Yes</b>	Parking lot:	<b>3725</b>
Number of doors:	<b>5</b>		
Number of seats:	<b>5</b>		
Number head rests:	<b>5</b>		
Rims summer:	<b>Aluminium</b>		
Category:	<b>Passenger Car</b>		
Oil level:	<b>OK</b>

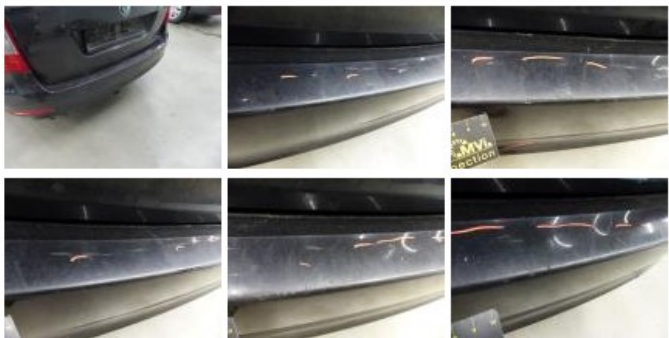
Assistance equipment			
Repair kit	<b>Yes</b>	Compressor	<b>Yes</b>
Total cost ex VAT			<b>1537,99</b>
Bumper R, Scratch(es), LI - Repair and paint (complete)			<b>254,16</b>
